Extracts from DDAAFS Safety Magazine “SIFTING THROUGH THE EVIDENCE”

13 September 1993 (F-111C A8-127) – 7th F-111 accident – ground impact near Guyra

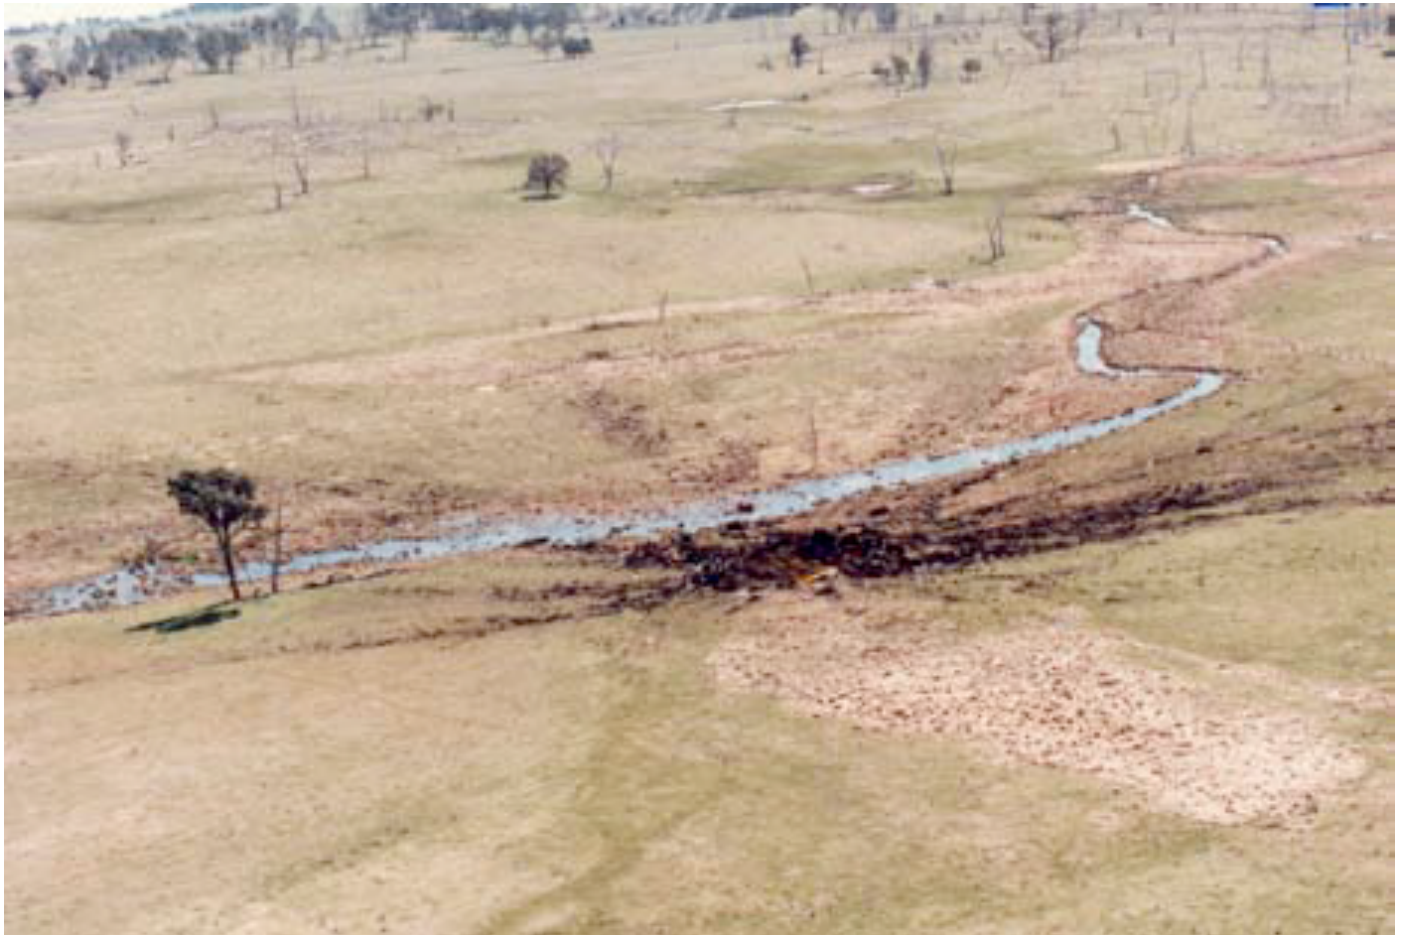
Impact crater – aircraft A8-127

1. The primary cause of the accident could not be determined.
2. The most probable cause of the accident was that the pilot, after omitting to disengage the Auto TF system on the pull-up² for the autotoss weapon delivery, through loss of situational awareness, placed the aircraft in a flight path vector from which impact with the ground was inevitable.

1. Review the 82 Wing categorisation scheme and currency requirements to reflect currency requirements for night flying and night weapon delivery profiles.
2. A standard 'patter' for the autotoss delivery should be used by all F-111C crews, this 'patter' should include the following:
 - a. The words 'pickle, paddle, pull' to indicate that the pilot has in fact paddled off, and
 - b. the words, 'three balls, rolling' to indicate that the pilot has in fact ensured that the three attitude indicators have been checked and that they correspond.
3. Pilots should depress the paddle switch for all autotoss deliveries (i.e. including manual flight deliveries).
4. Abort procedures for autotoss deliveries be documented in the 82WG F-111 SOPs.
5. Air Command should introduce a formal risk management process that addresses crew/task matching.

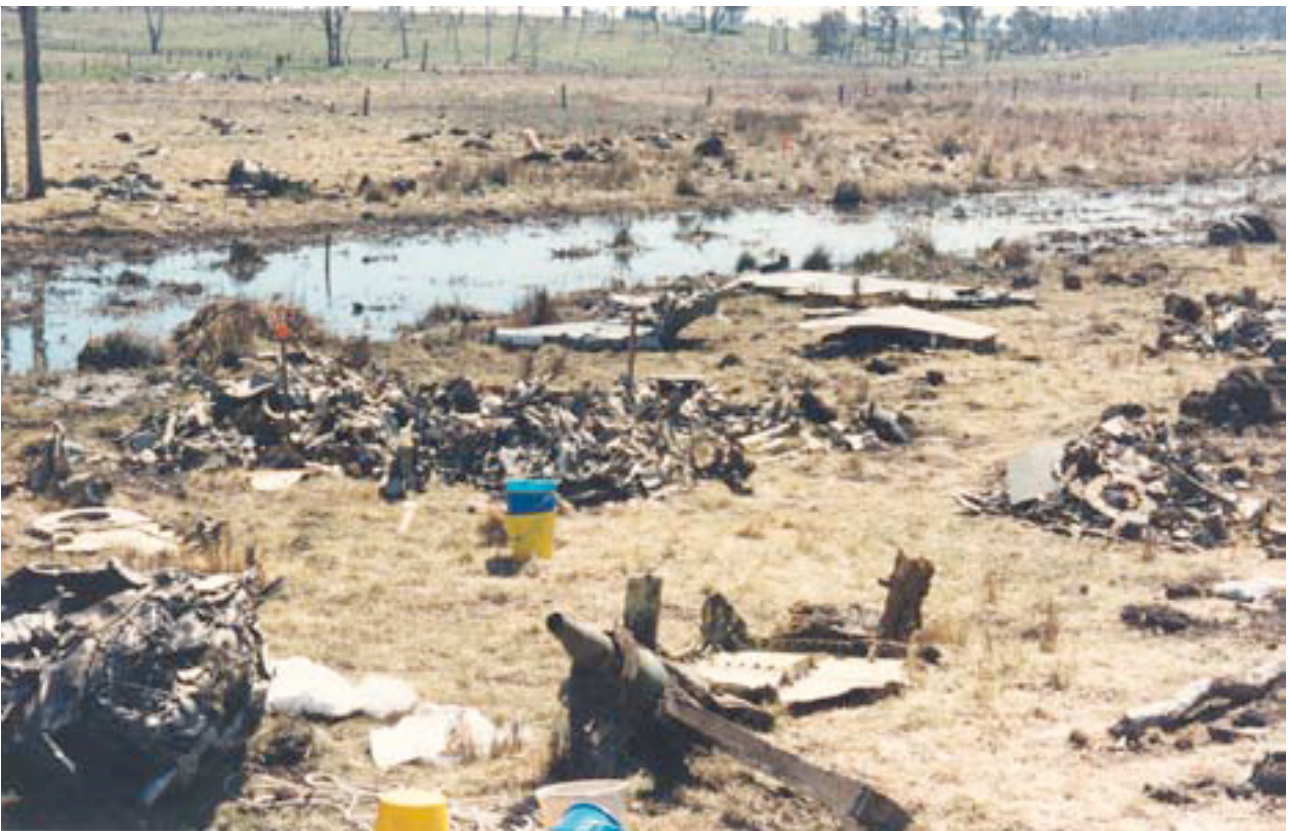
Wreckage recovery - aircraft A8
