## **Extracts from DDAAFS Safety Magazine “SIFTING THROUGH THE EVIDENCE”**

**28 January 1986 (F-111C A8-139) – 5<sup>th</sup> F-111 accident – sea impact off coast of Moruya**

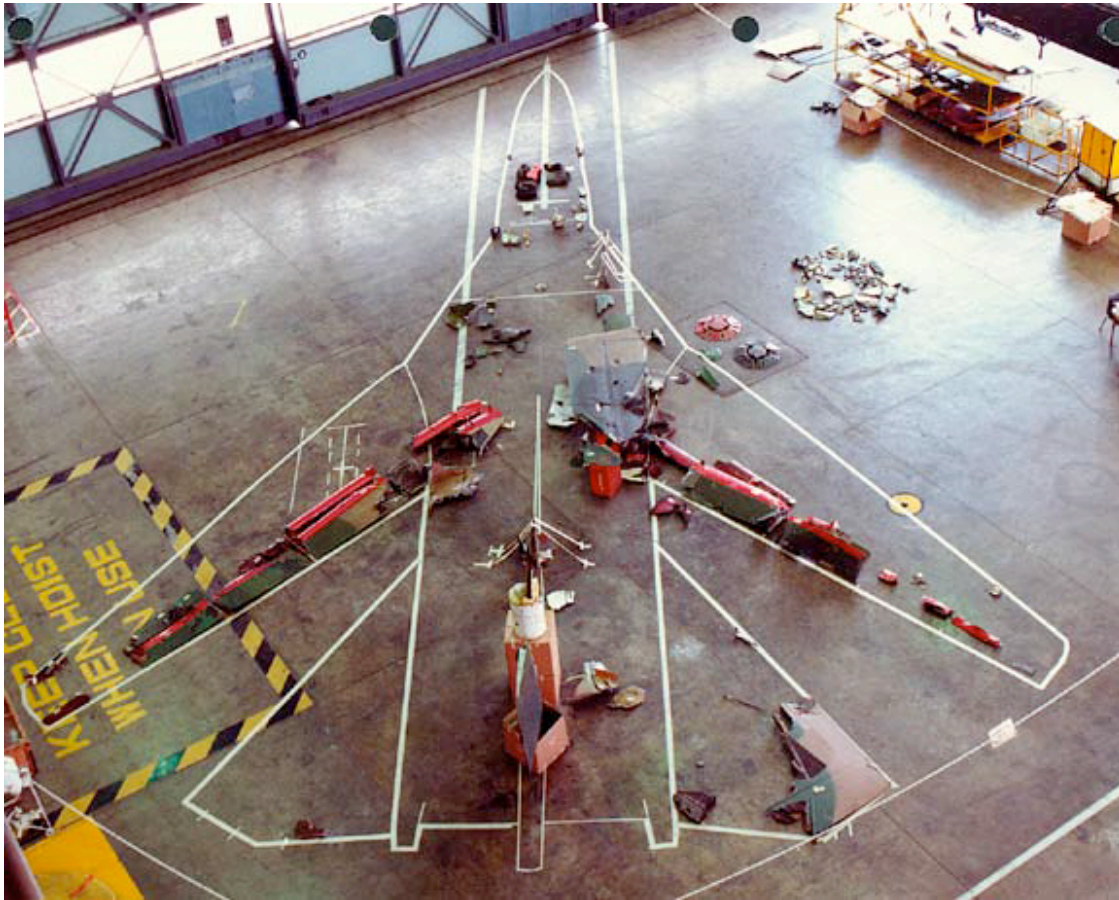
The incident crew were leading a fleet support maritime strike mission involving four F-111 aircraft. Approximately 1800 lbs of wreckage (about 3% of the aircraft's total weight) was recovered from the ocean surface,<sup>1</sup> with indications that an ejection was not attempted and that both crew members died on impact. Weather at the time was 6/8 cloud cover with a base of 2500 ft and tops of 5500 ft. Conditions were very dark, with the moonrise (full moon) due to occur approximately 20 minutes after the accident.

**Layout of total wreckage recovered – aircraft A8-139**
