Extracts from DDAAFS Safety Magazine “SIFTING THROUGH THE EVIDENCE”

25 October 1978 (F-111C A8-141) – 3rd F-111 accident – inflight fire and ejection near Auckland

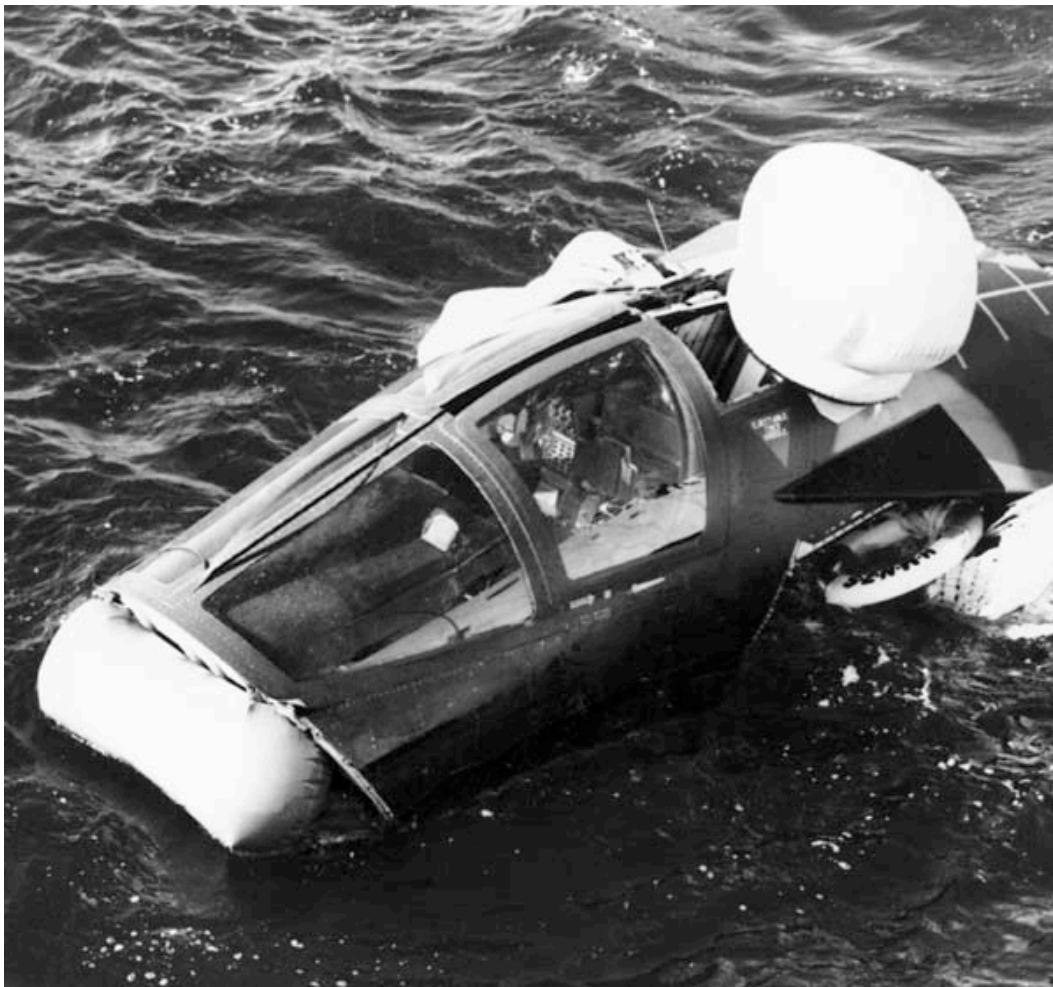
Crew module – aircraft A8-141

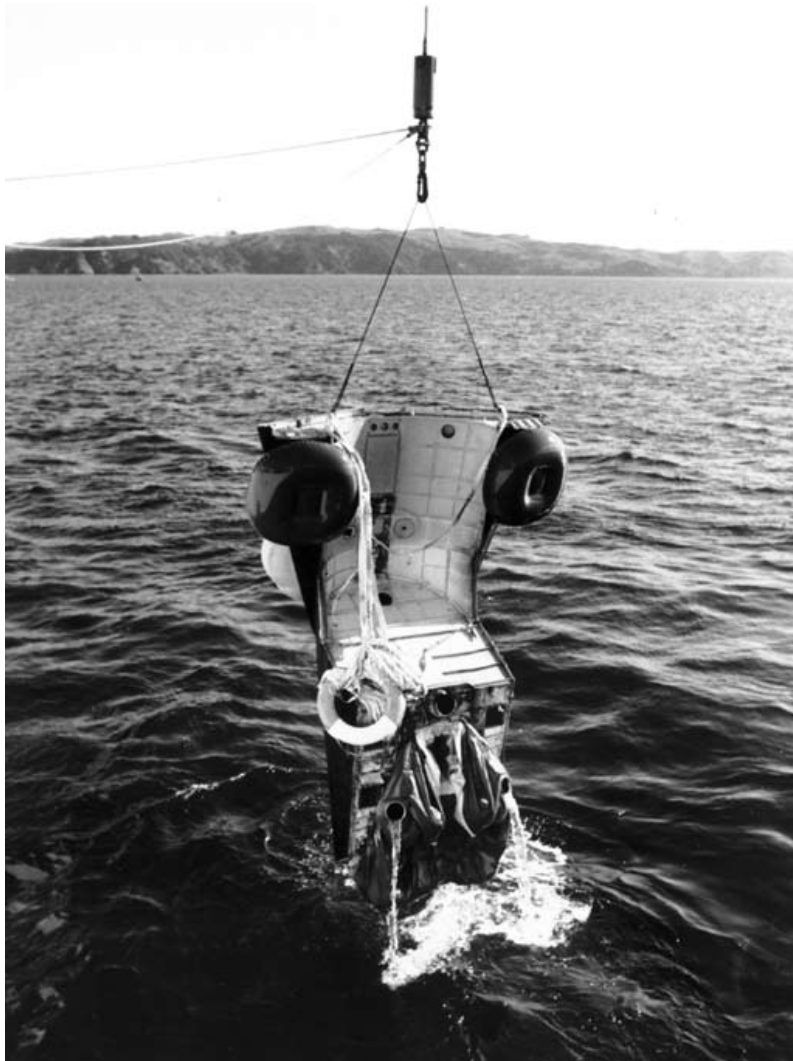
Crew module extraction – aircraft A8-141
