A8-130 – On-board Fire & Primary Hydraulic System Failure

<p>SUBJ: AVIATION SAFETY OCCURRENCE REPORT: 6SQN-075-2007</p>				
<p>REFERENCES:</p> <p>A. AAP 7214.010-6-1M</p>				
<p>1. SERIOUS INCIDENT</p>				
<p>2. MATERIEL/ENGINE/ENGINE FIRE AND HYDRAULIC FAILURE</p>				
<p>3. 01 1530 LOCAL OCT 07</p>				
<p>4. LOCATION: OTHER - PLEASE SPECIFY/YCCA/290/35</p>				
<p>5. ENVIRONMENTAL CONDITIONS: DAY/VMC/N/A</p> <p>WEATHER: SMOKE HAZE</p>				
<p>6. AIRCRAFT DETAILS:</p> <p>F-111/A08C/130/SONIC 1</p> <p>SPEED: 500 TO 600 KIAS</p> <p>ALTITUDE: GREATER THAN 2000 FEET AMSL</p> <p>FLT PATH: CLEAR</p> <p>FLT PHASE: DESCENT</p> <p>LAST DEPARTURE POINT: YAMB</p> <p>INTENDED LANDING POINT: YAMB</p> <p>MISSION: TRAINING/AP13P - OPCON DAY APPLIED PHASE</p>				
DRAFTER'S NAME AND TITLE		OPERATOR		PHONE No
RELEASER'S NAME AND TITLE		BRANCH/UNIT		SIGNATURE
DATE		No OF PAGES		PAGE No
8/10/2007		4		1
				OVERPAGE
				Yes

Defence Aviation Hazard Reporting & Tracking System

Title: Materiel / Engine / ENGINE FIRE AND HYDRAULIC FAILURE

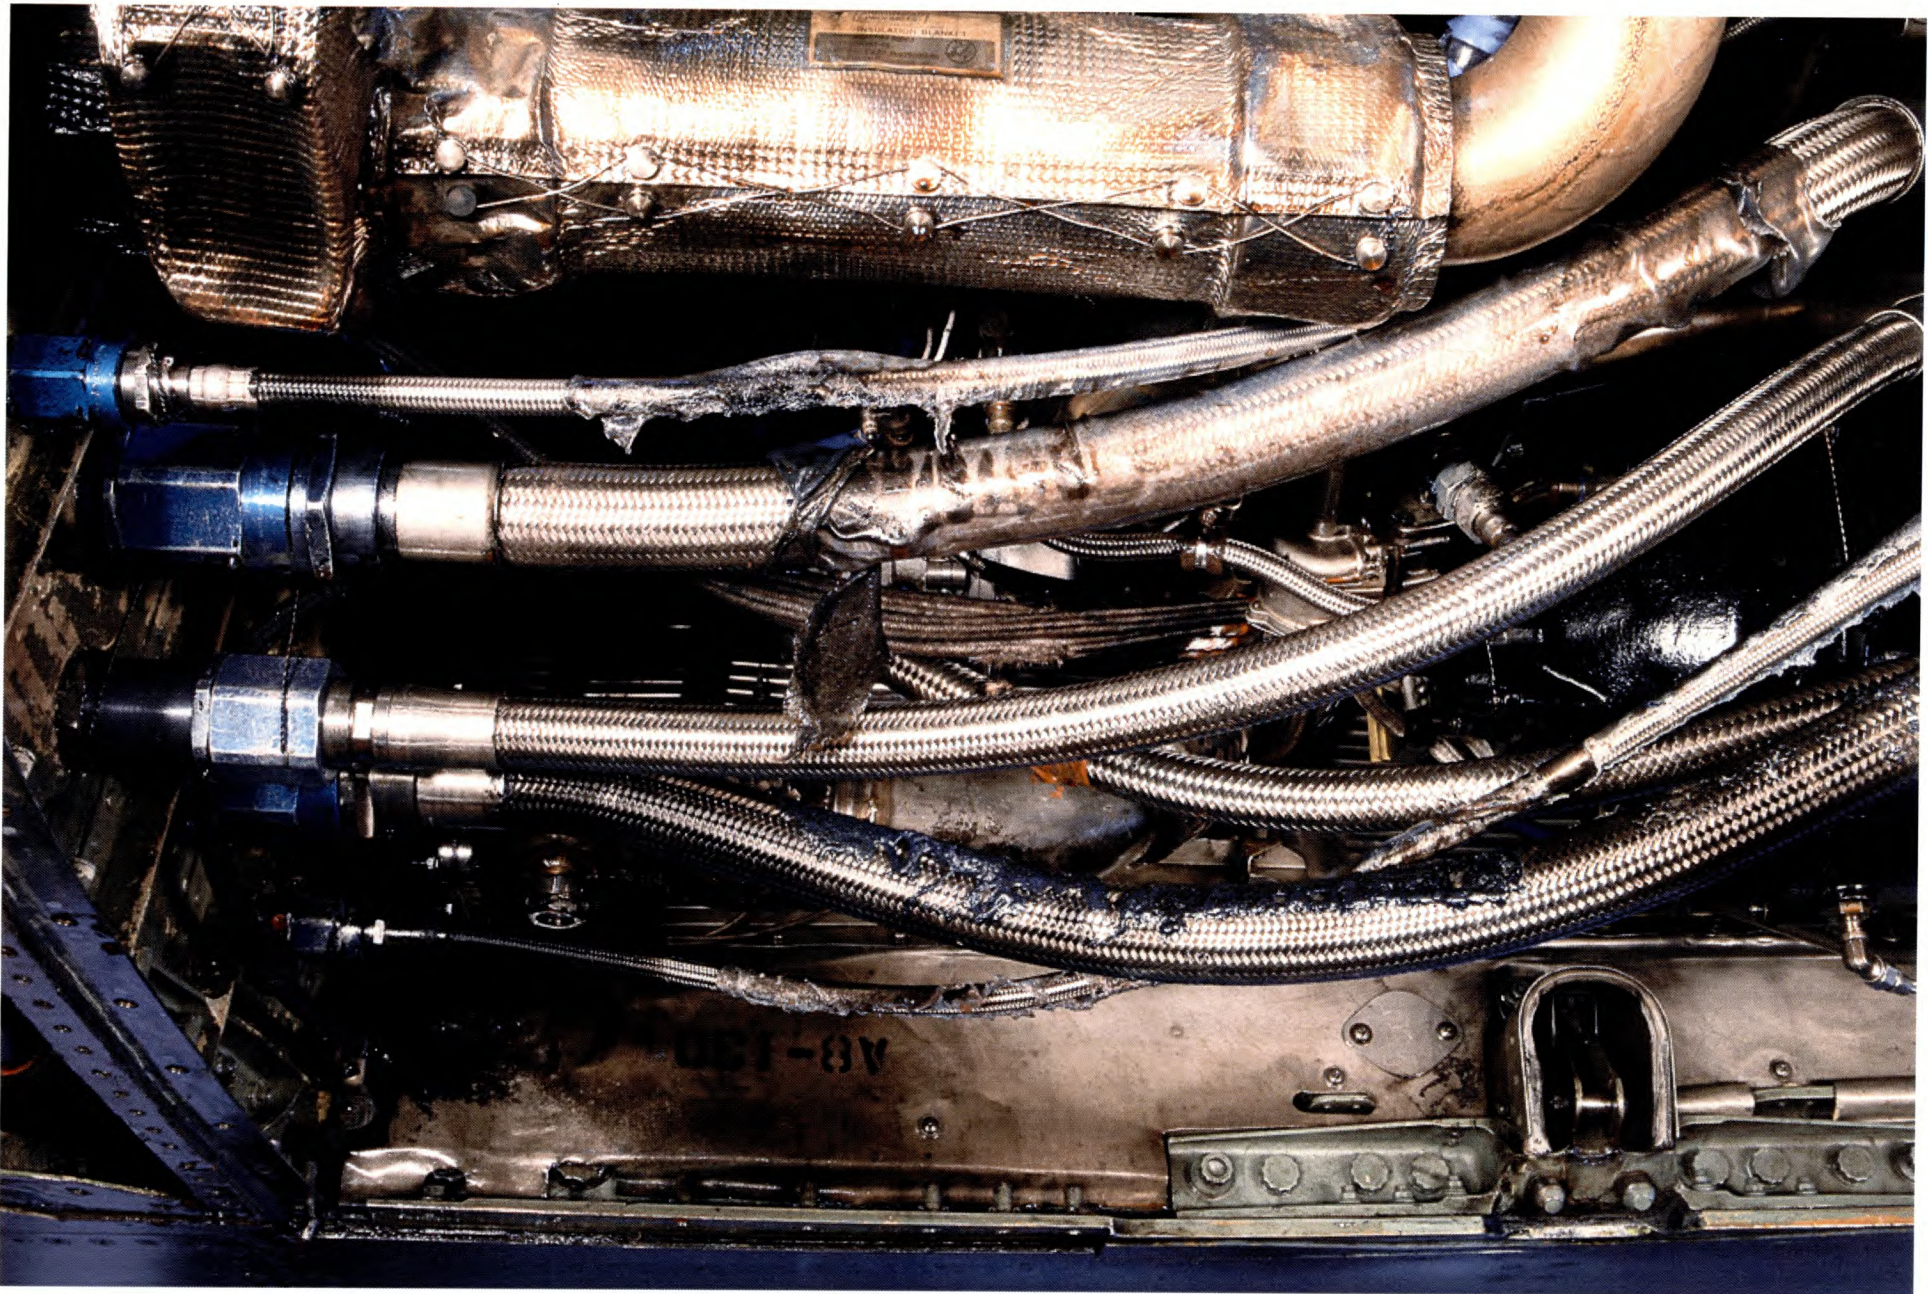
A8-130 – LH Engine Bay

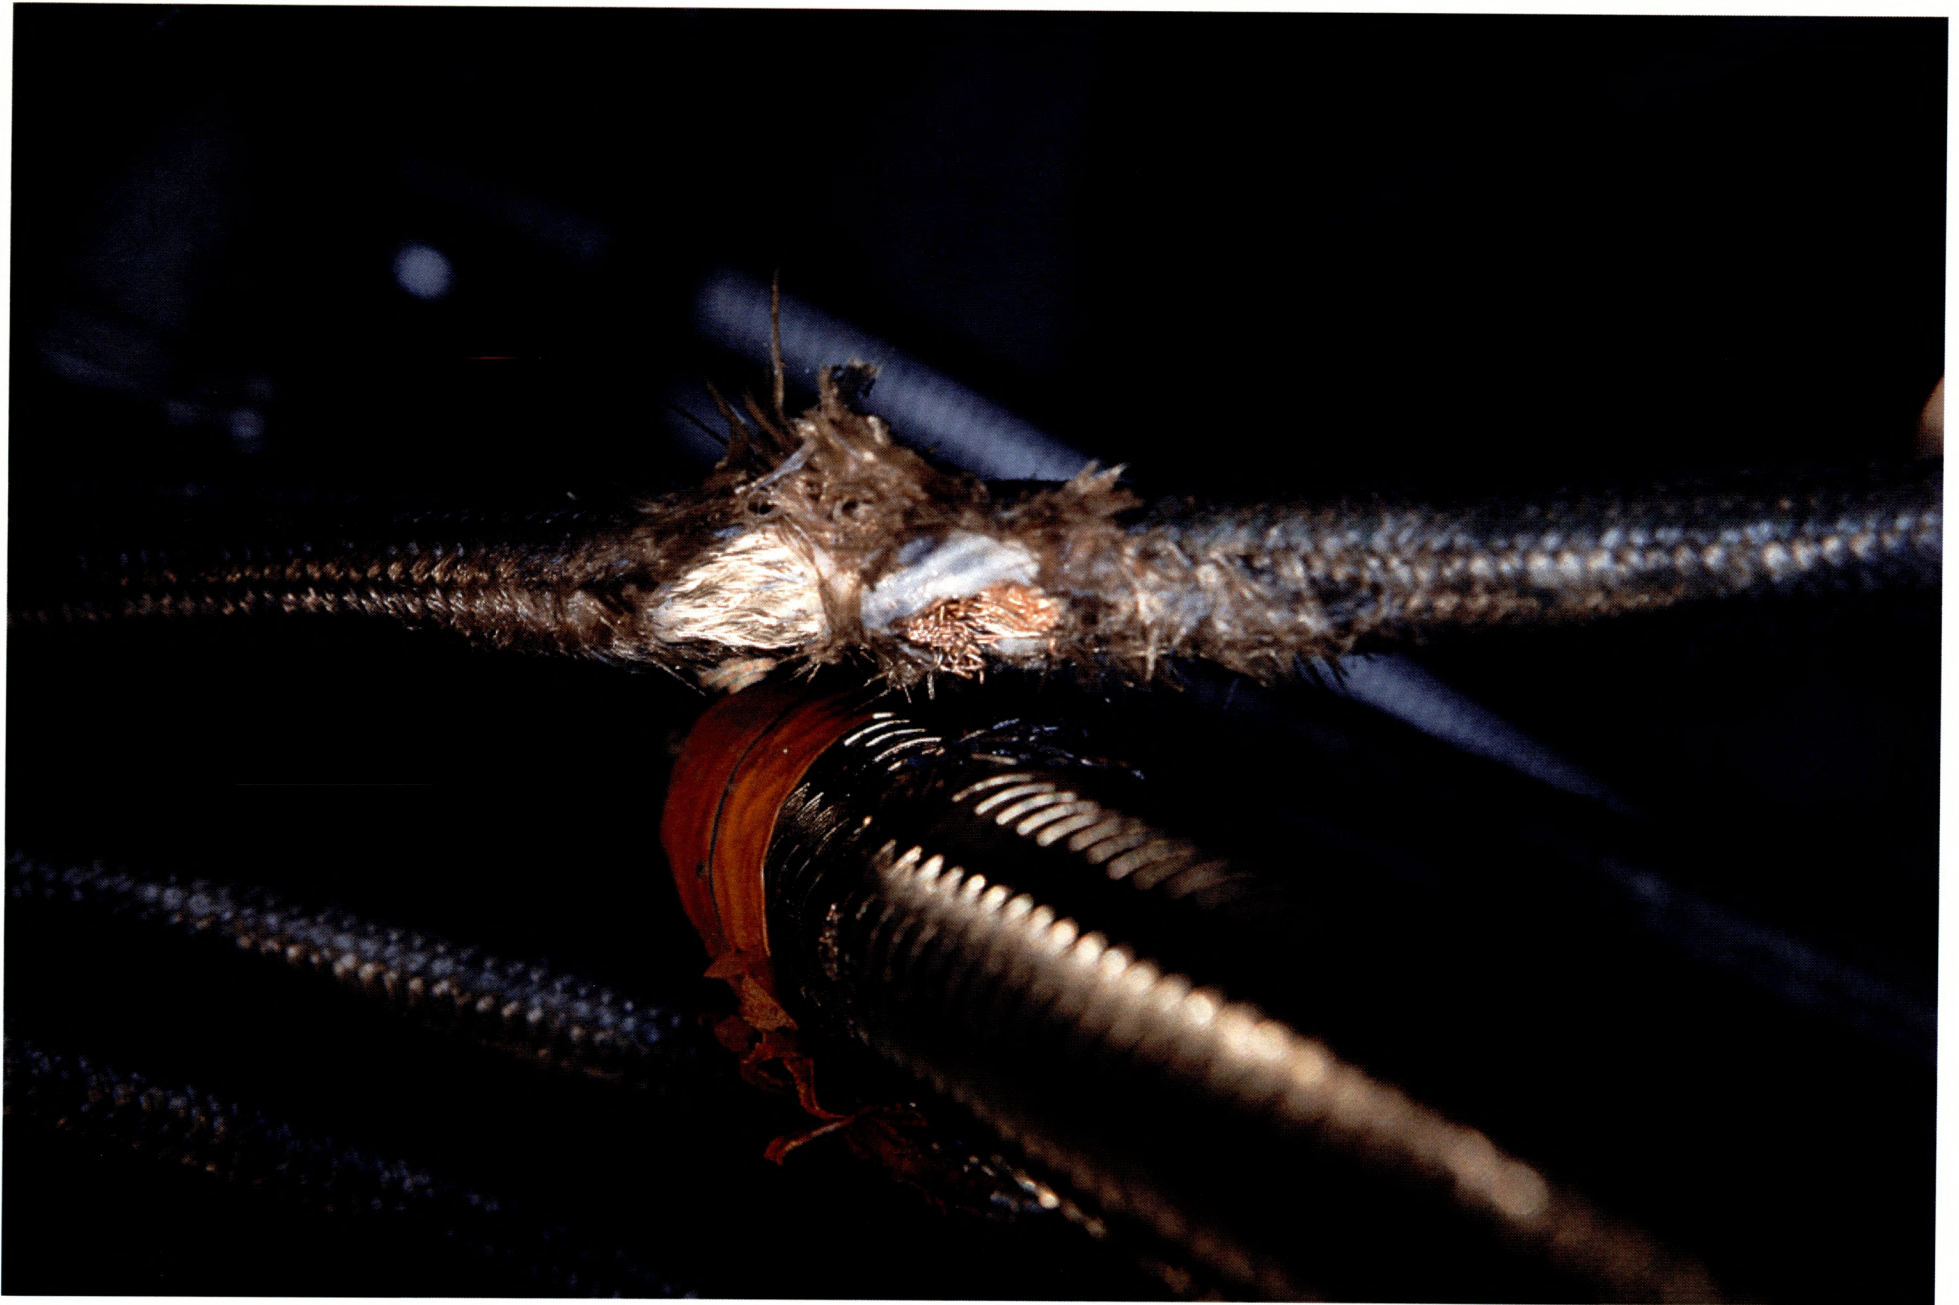
A8-130 – LH Engine – Chaffing between Generator DC Cable and Primary Hydraulic Pump Pressure Line

A small hole was found on the LH primary hydraulic pump line approximately 30cm aft of the firewall. An AC power line in close vicinity to the small hole showed excessive signs of wear.

Visual inspection of the AC power line showed the internal wires were bare and chaffing damage.

It is likely that the failure is a function of two faults. The first being excessive chaffing to both the hydraulic line and the AC power line. The second being electrical arcing between the two lines.

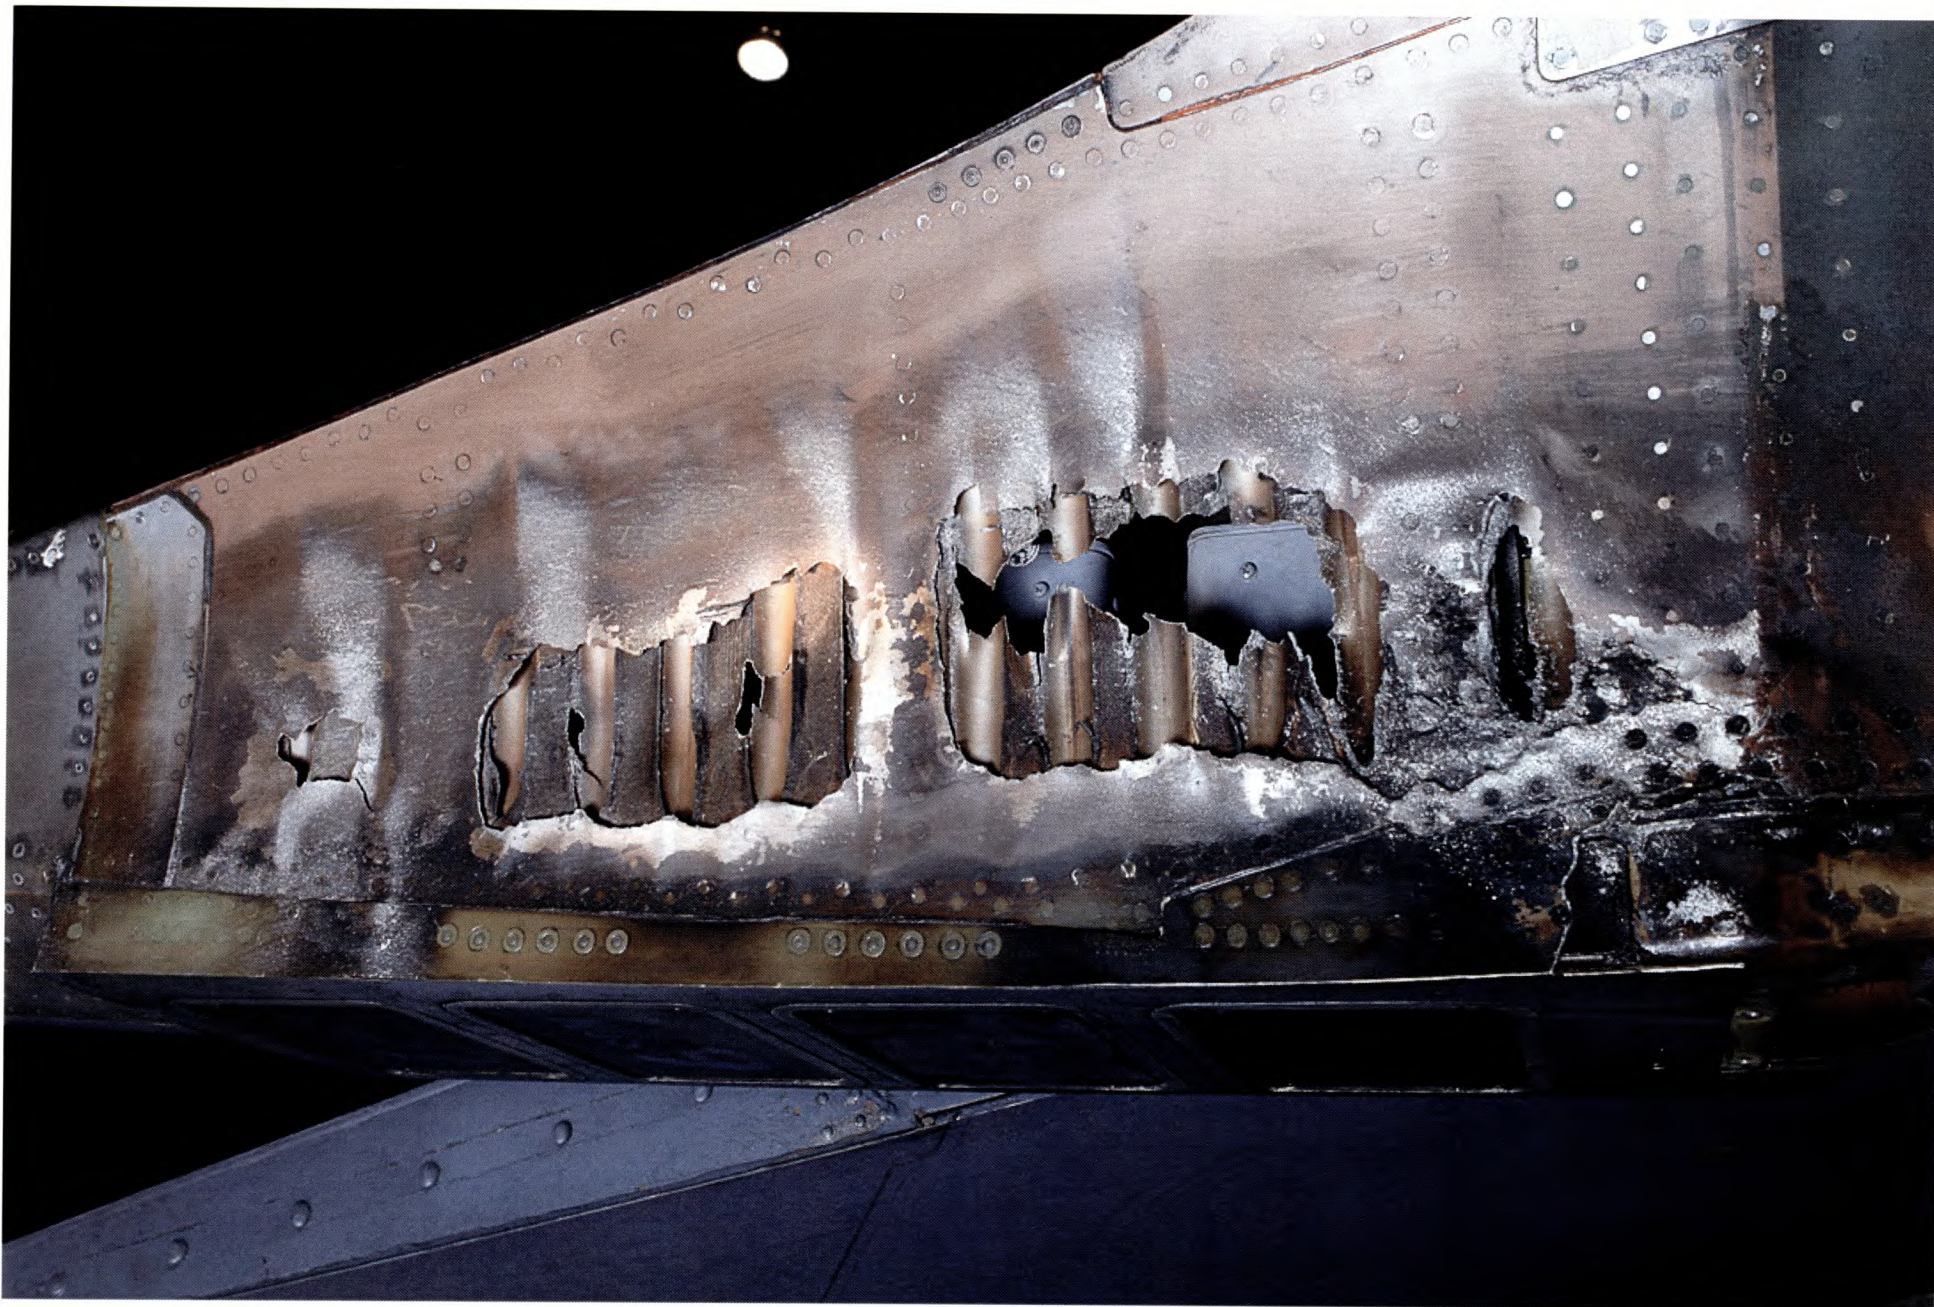
A8-130 – LH Chaff Bucket Area

Inspection of the LH speed bump area showed significant signs of fire damage, in close vicinity to the chaff and flare installation areas.
