Extracts from DDAAFS Safety Magazine
“SIFTING THROUGH THE EVIDENCE”
(RAAF F-111 aircraft and crew losses)

28 April 1977 (F-111C A8-136) – 1st F-111 accident – inflight fire and ejection near Tamworth

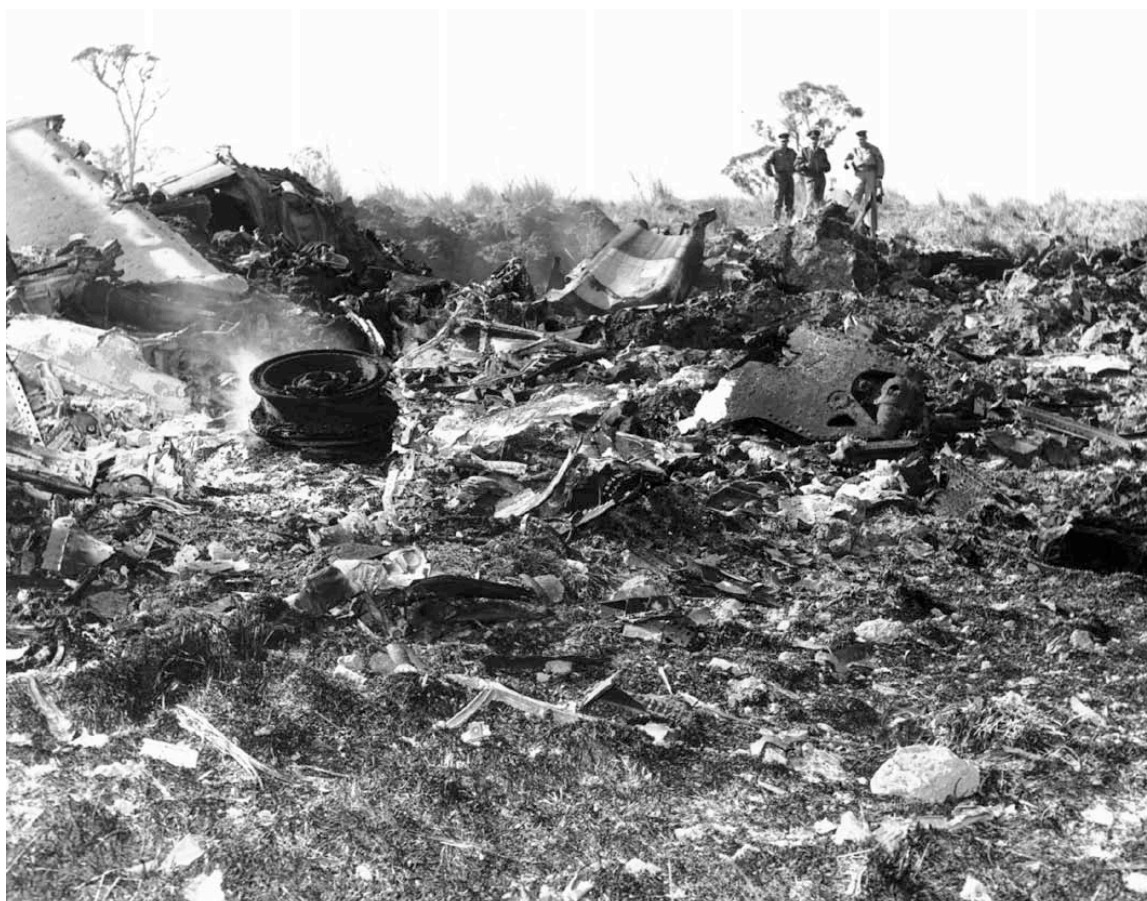
Wreckage site – aircraft A8-136

Wreckage analysis, including that collected 7 miles short of the aircraft ground impact point, indicated that the inflight explosion blew off the upper surface of the rear left hand saddle fuel tank and also probably ruptured the forward main fuel tank.
