## **Extracts from DDAAFS Safety Magazine**

### **“SIFTING THROUGH THE EVIDENCE”**

#### **24 August 1979 (F-111C A8-137) – 4<sup>th</sup> F-111 accident – aborted take-off and ejection Ohakea airbase**

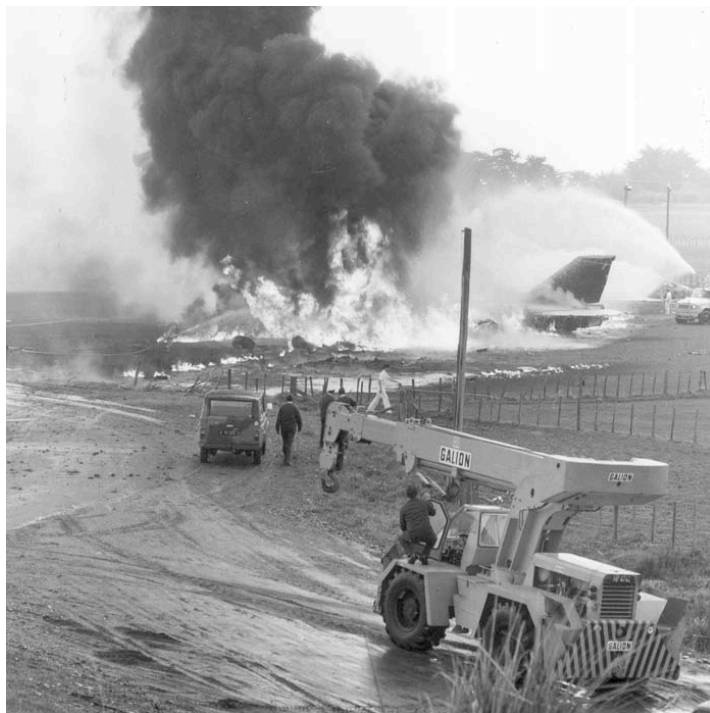
During an aborted take-off above refusal speed<sup>1</sup> following a double engine surge and afterburner blowout (caused by ingestion of surface water excited by the aircraft's nosewheels) the aircraft was unable to be stopped within the remaining runway. The navigator initiated ejection at 90 kts and approximately 150 ft from the end of the runway. The aircraft continued down the slope beyond the runway (a drop of 100 ft only 30 ft from the end of the runway) where it impacted a roadway embankment and caught fire. The ejection was successful, however, the pilot suffered considerable back injuries.

**Abort above refusal speed – aircraft A8-137**

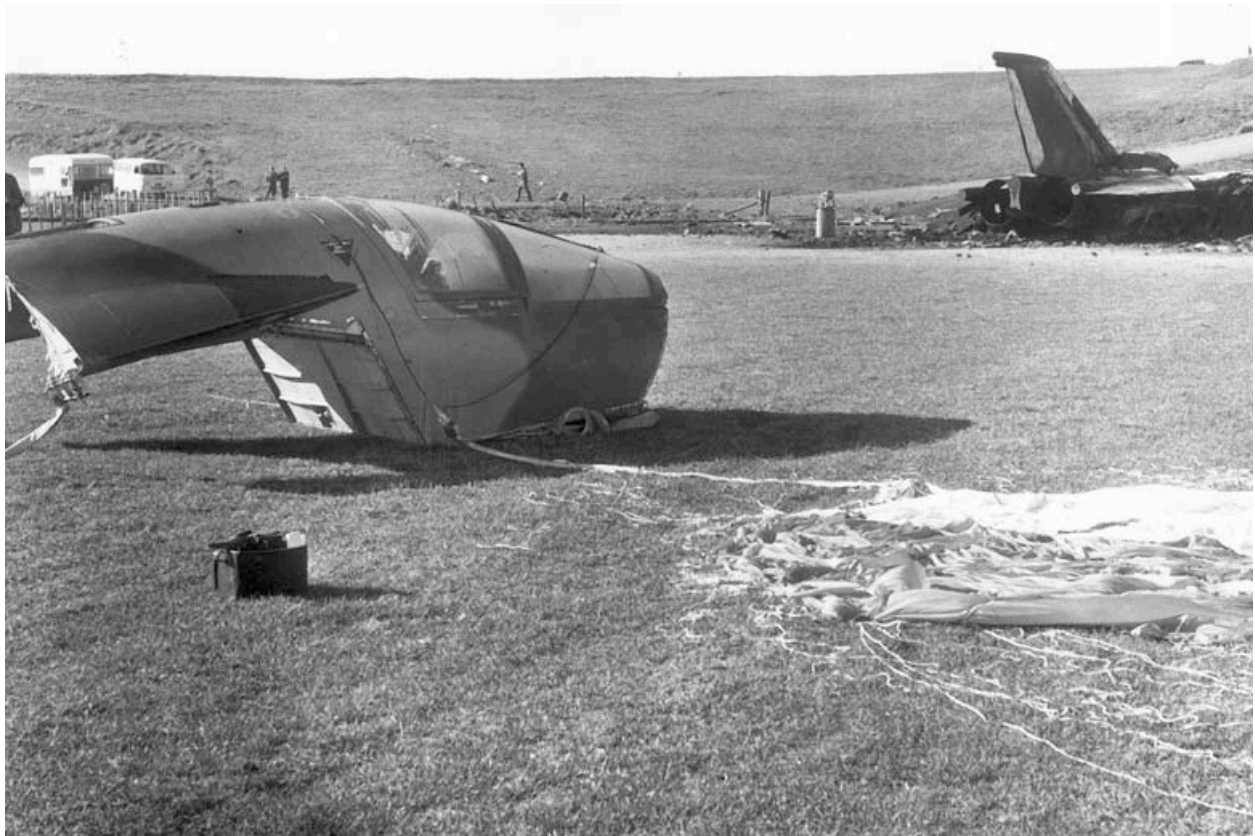
realised that the hookcable was not rigged [it had been removed prior to the F-111s' take-off so that the RNZAF A-4s did not have to land beyond a rigged hookcable during their ground controlled approaches (GCAs) to RWY 09]. With 800 ft of runway remaining, the navigator realised that ejection was the only chance of survival and informed the pilot. With the pilot still attempting to stop the aircraft, the navigator initiated ejection about 150 ft from the end of the runway. The crew module separated as the nosewheel left the pavement at the end of RWY 27. The aircraft continued down the 100 ft drop-off, impacted a roadway embankment and caught fire before sliding to a halt, some 100 ft below and 500 ft from the departure end of RWY 27. The ejection module landed approximately 145 ft from the burning wreckage. Fearing the fire may spread towards the module, the navigator extracted and carried the injured pilot from the module.

**Crew module proximity to crash site – aircraft A8-137**
