Extracts from DDAAFS Safety Magazine

“SIFTING THROUGH THE EVIDENCE”

18 April 1999 (F-111G A8-291) – 8th F-111 accident – ground impact Pulau Island Malaysia

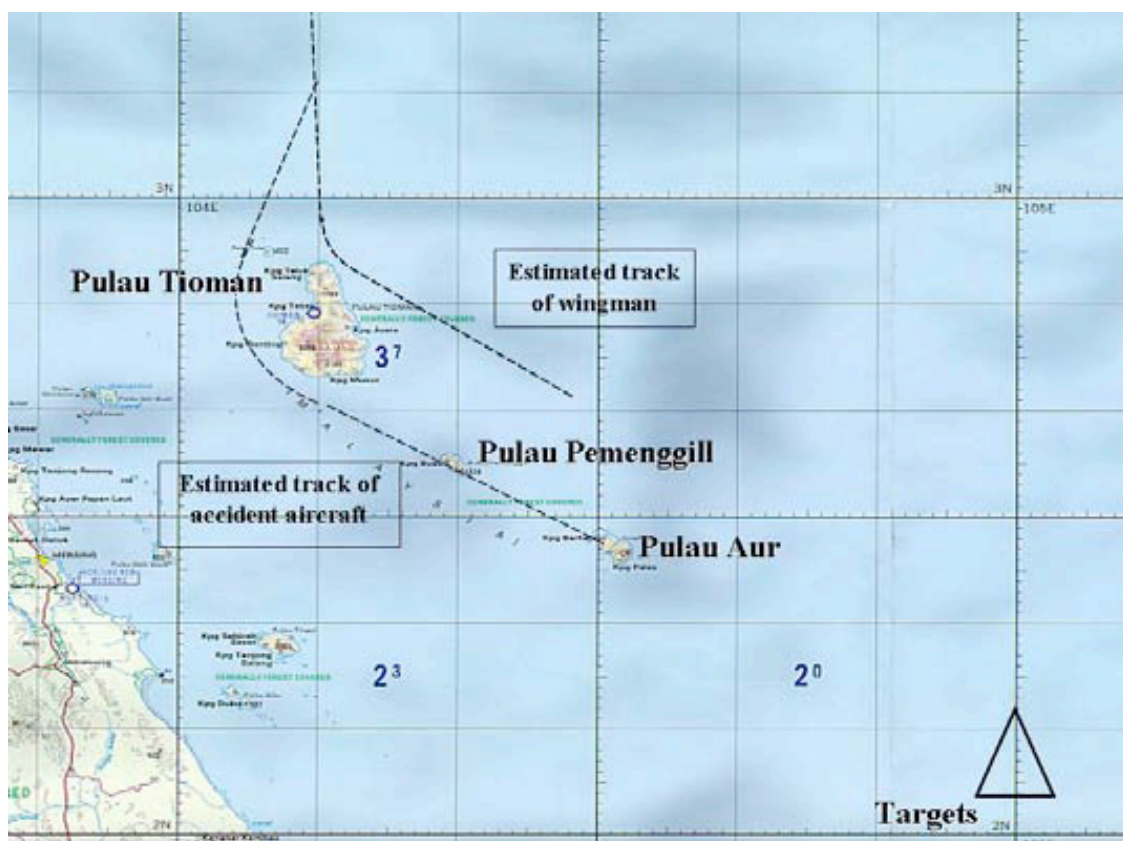
Estimated track to impact point – aircraft A8-291

During a night simulated maritime strike attack, the aircraft impacted trees on an 1100 ft ridge on Pulau Aur (Aur Island), 24 nm to the south east of Pulau Tioman (Tioman Island), and off Malaysia’s east coast. The aircraft was destroyed during the impact and subsequent fire. Both crew members were killed.

Accident reconstruction indicates that the incident crew used TFR during the low level overwater segment to Tioman Island. In the targeting phase the pilot disengaged the TFR system. The navigator experienced some difficulty in targeting the naval task force and may have become task saturated during the targeting process – the F-111G is not Harpoon capable and requires the navigator to effect a time consuming work-around procedure to get the required aircraft system indications for simulated weapon release. Once the targeting was complete the pilot manually descended the aircraft to 1000 ft AMSL (TFR was not used). The navigator was then preoccupied with compiling the information required for the ‘Bruiser’ radio call that informs the targeted naval force of F-111 weapon release, and did not observe the radar returns of the two smaller islands directly ahead of the aircraft. At five seconds before aircraft impact the radar altimeter’s low altitude audible warning sounded and the radar altitude bars were visible in the attack radar – the latter warning is unique to the F-111G.⁴ Indications are that the pilot may have responded to an unexpected visual sighting and attempted to climb the aircraft, however the aircraft impacted trees on a ridge on the island, killing both members instantly.
