# SIFTING THROUGH THE EVIDENCE

RAAF F-111 and AF/A-18 aircraft and crew losses

An aviation safety magazine of the Australian Defence Force

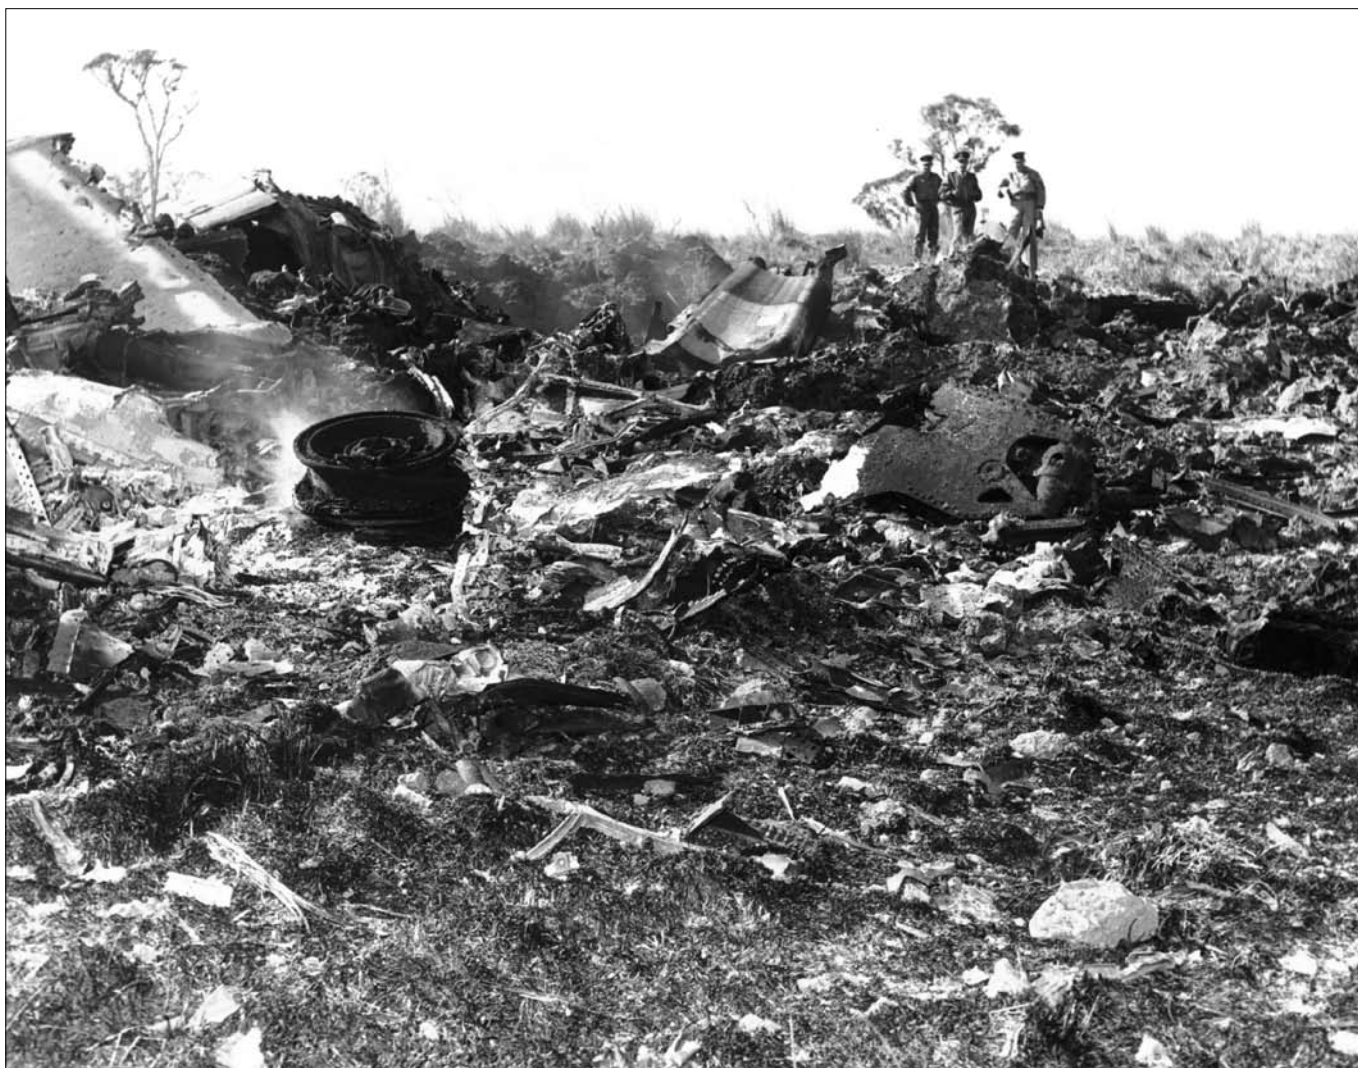
Below: Wreckage site 14 nm north of Armadale – aircraft A8-136.

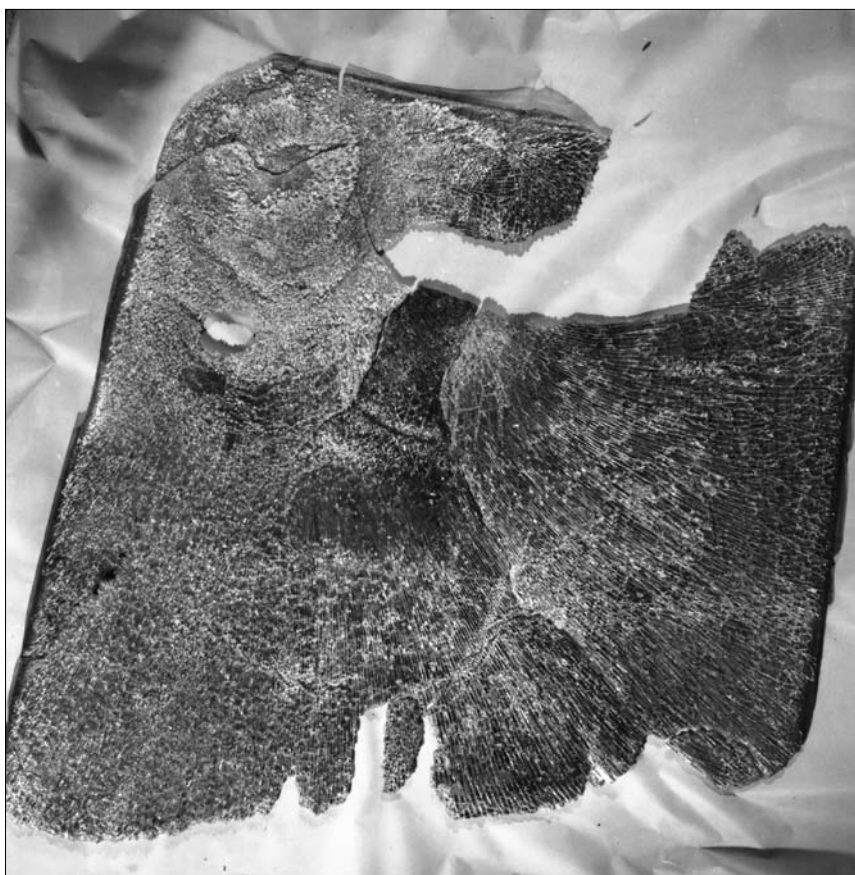
**Right: Birdstrike damage to pilot's side canopy – aircraft A8-133.**

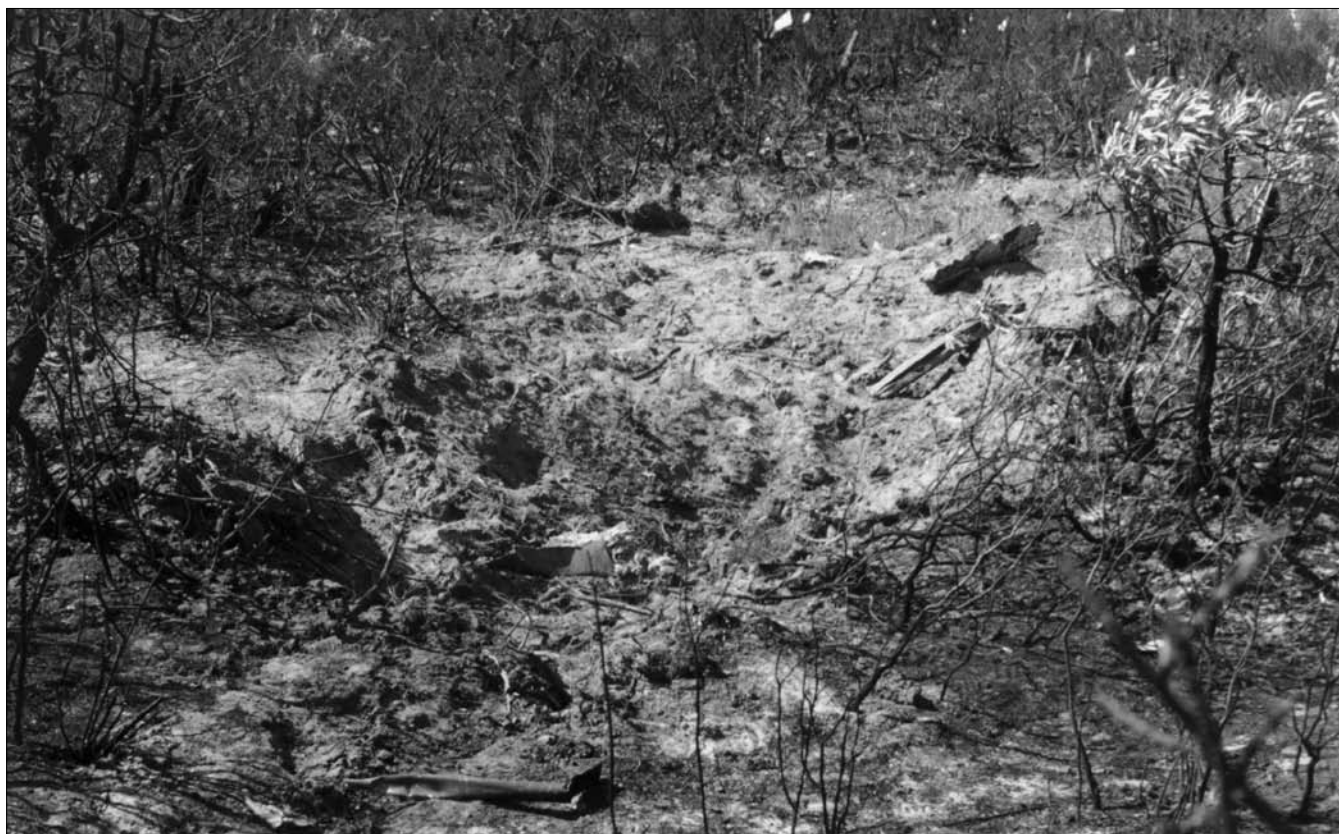
**Below: Crew module crater – aircraft A8-133.**

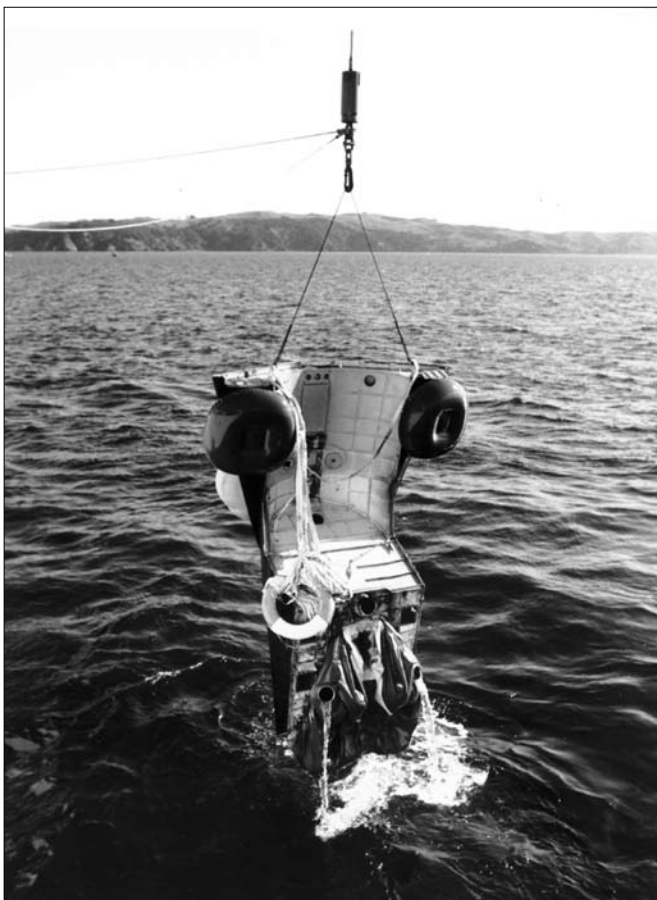
Left: Crew module extraction - aircraft A8-141.

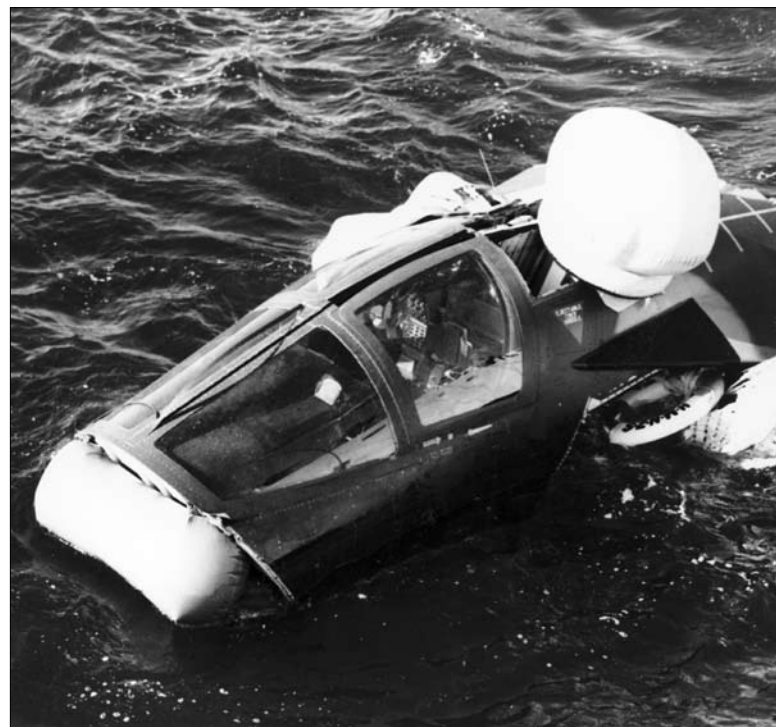
Below: Crew module - aircraft A8-141.

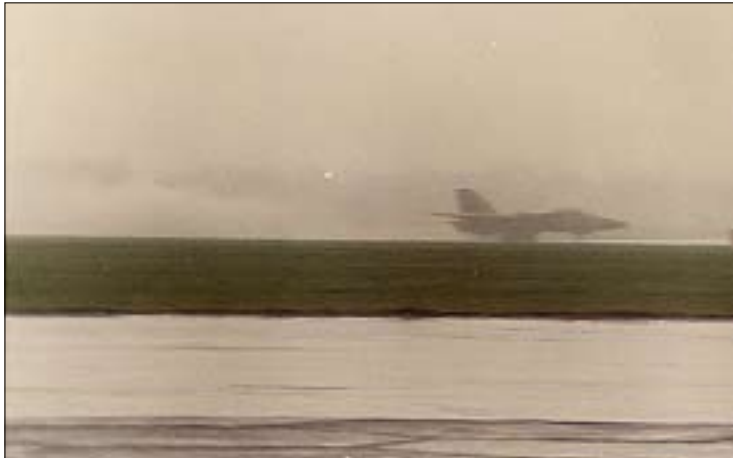
Left: Take-off conditions at Ohakea airbase on 24 August 1979  
– aircraft A8-137.

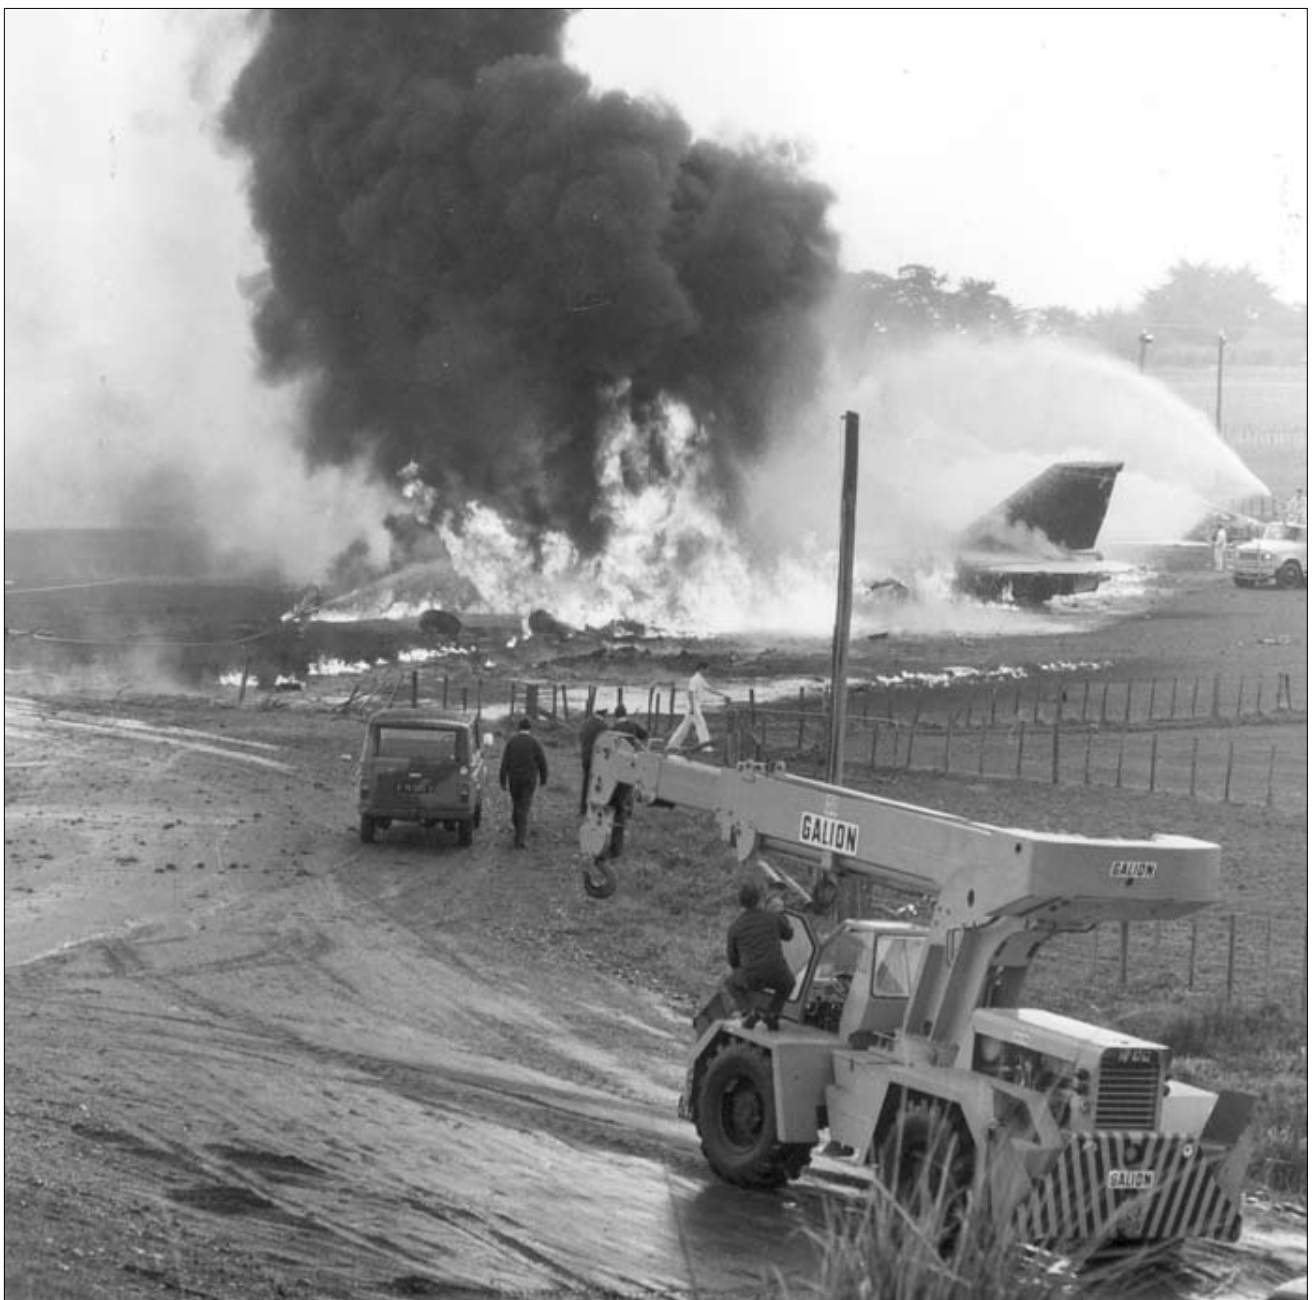
Below: Abort above refusal speed – aircraft A8-137.

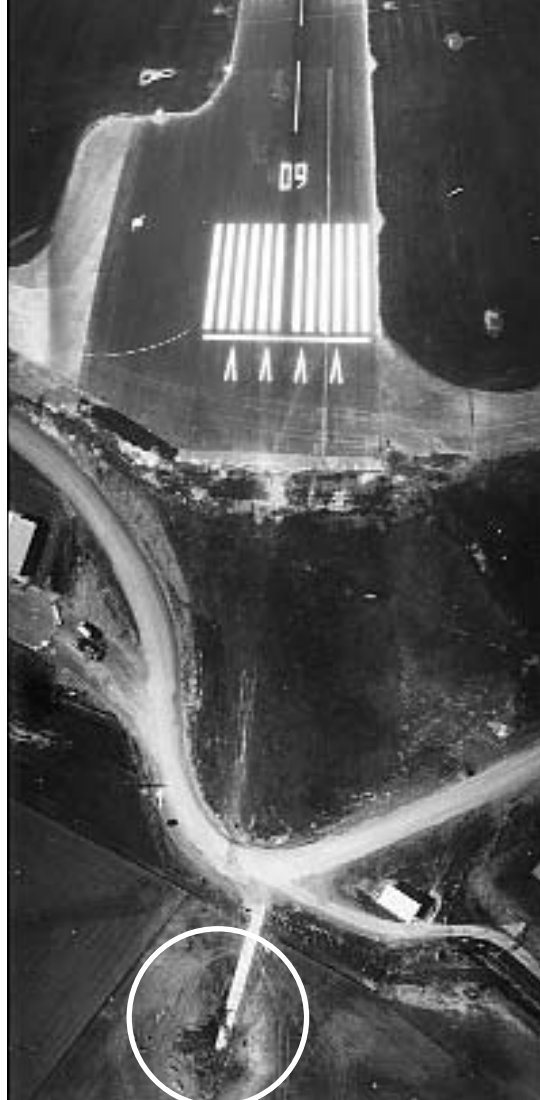
**Right: Overhead of crash site (circled) and runway drop-off (the white line to the right of the runway number marking is the slot-drain) – aircraft A8-137.**

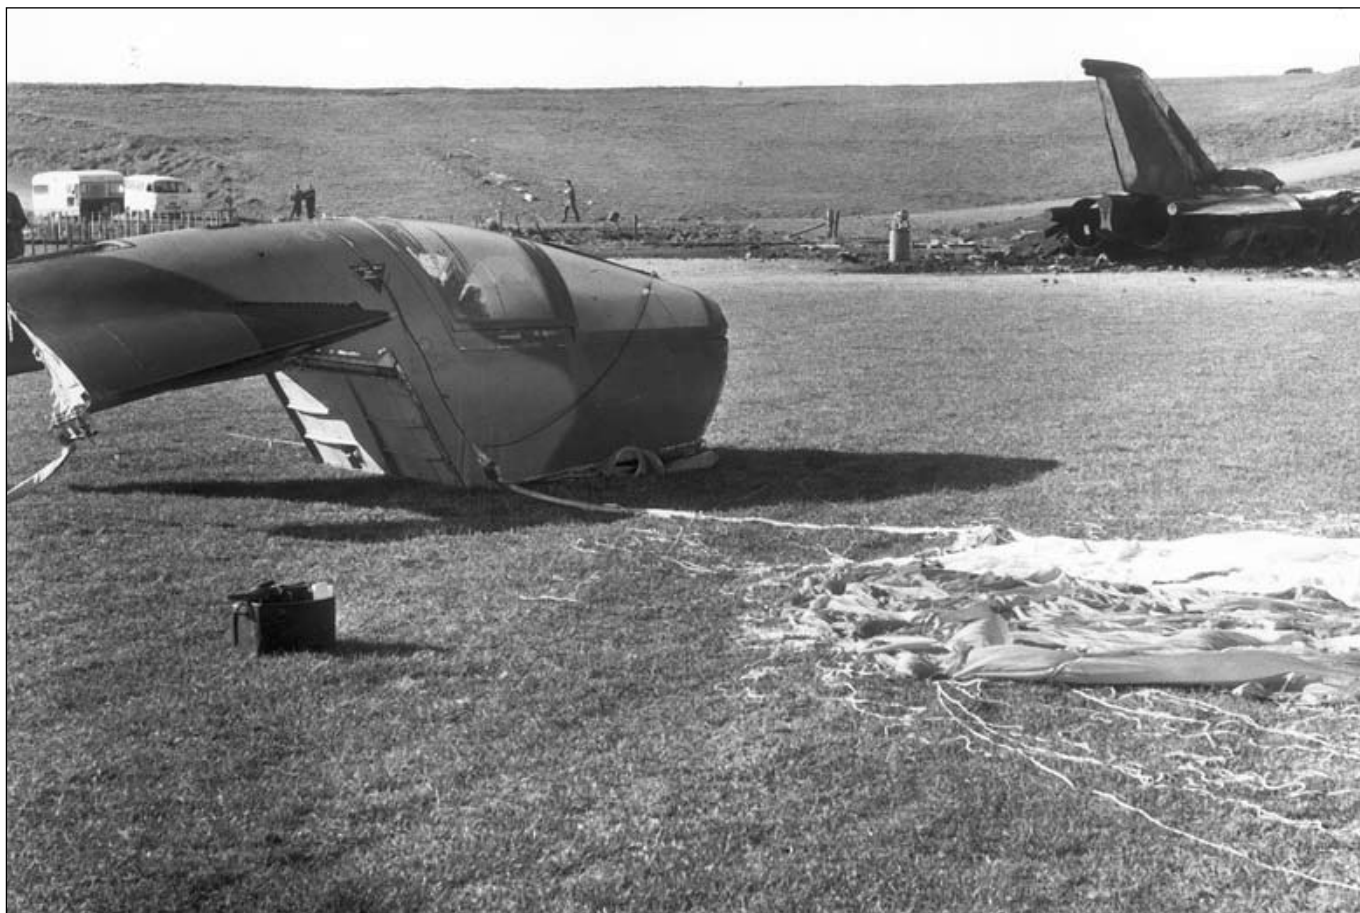
**Below: Crew module proximity to crash site – aircraft A8-137.**

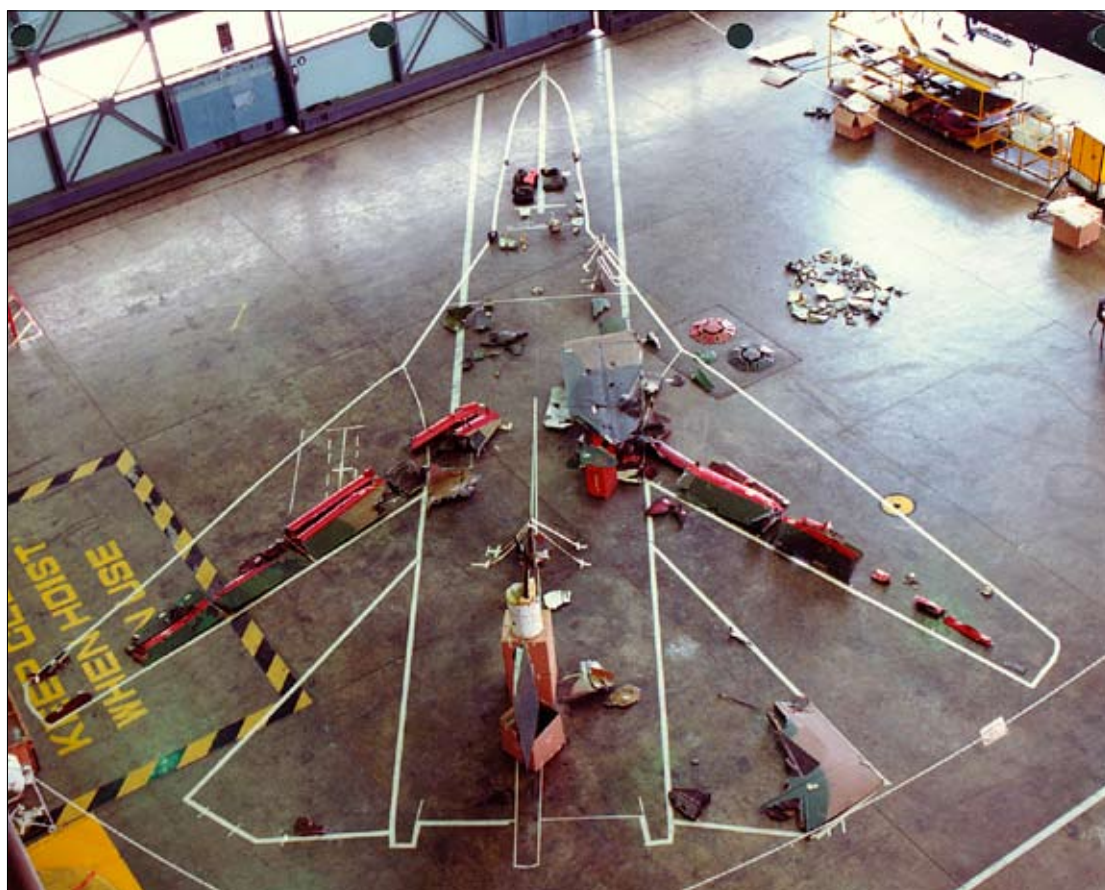
**Right: Layout of total wreckage recovered – aircraft A8-139.**

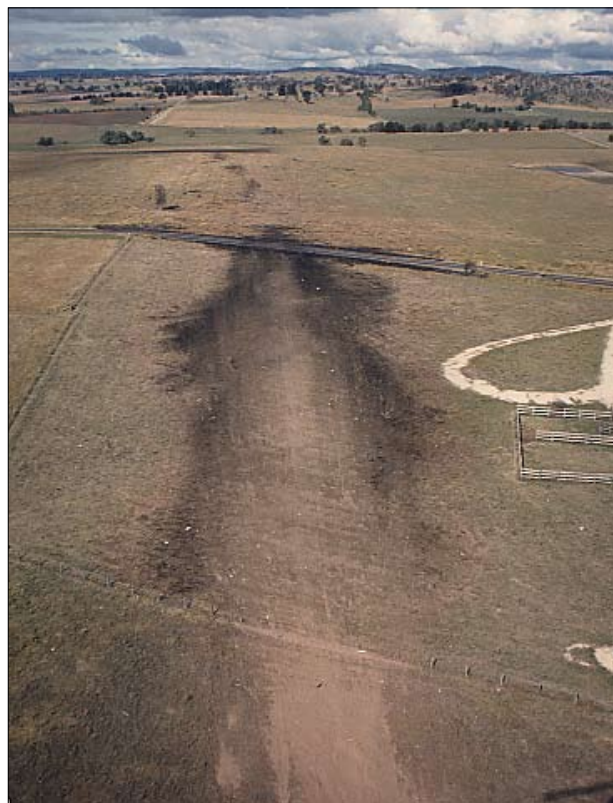
Above: Ground impact scar – aircraft A8-128.

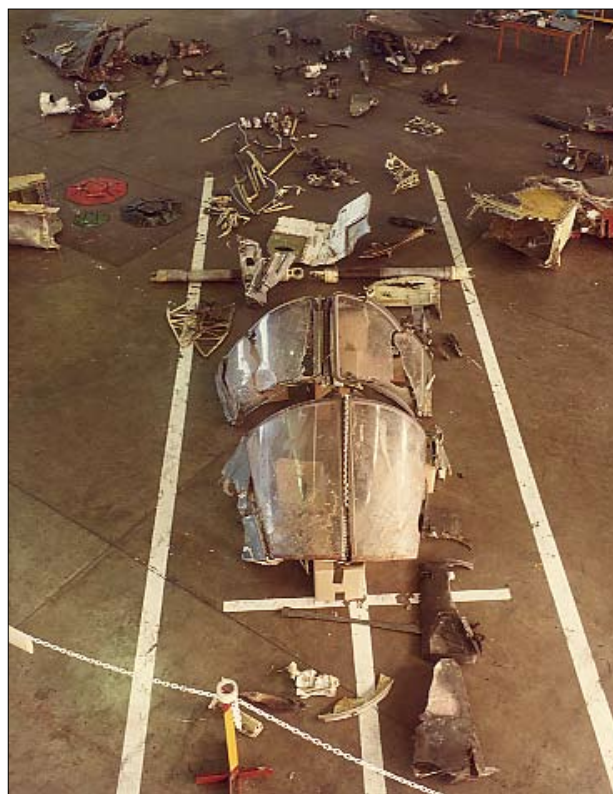
Below: Wreckage reconstruction – aircraft A8-128.

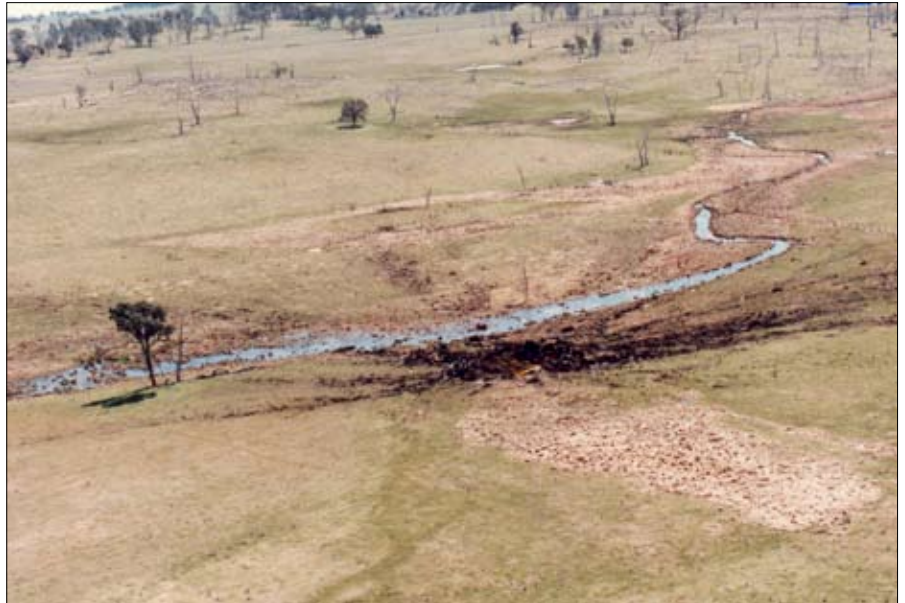
Above: Impact crater near Guyra – aircraft A8-127.

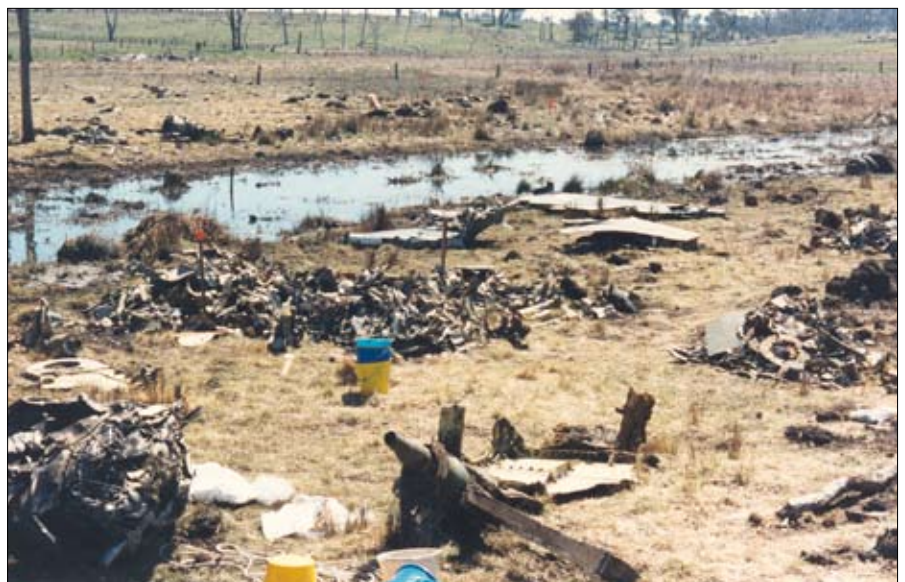
Below: Wreckage recovery – aircraft A8-127.

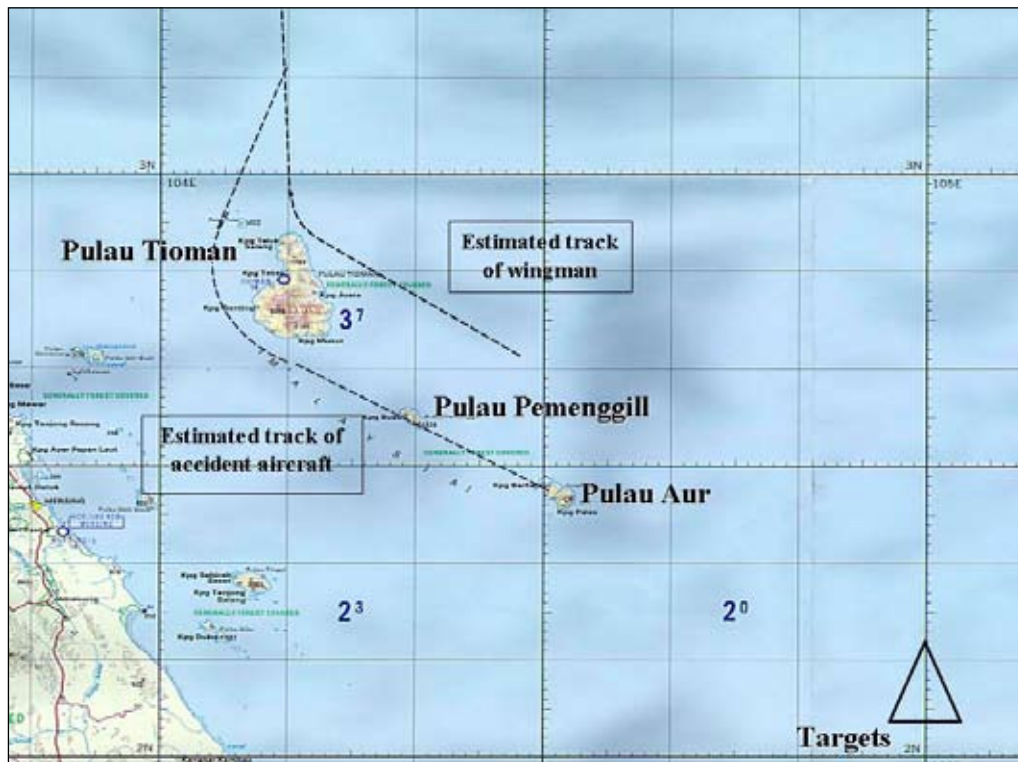
Left: Estimated track to impact point – aircraft A8-291

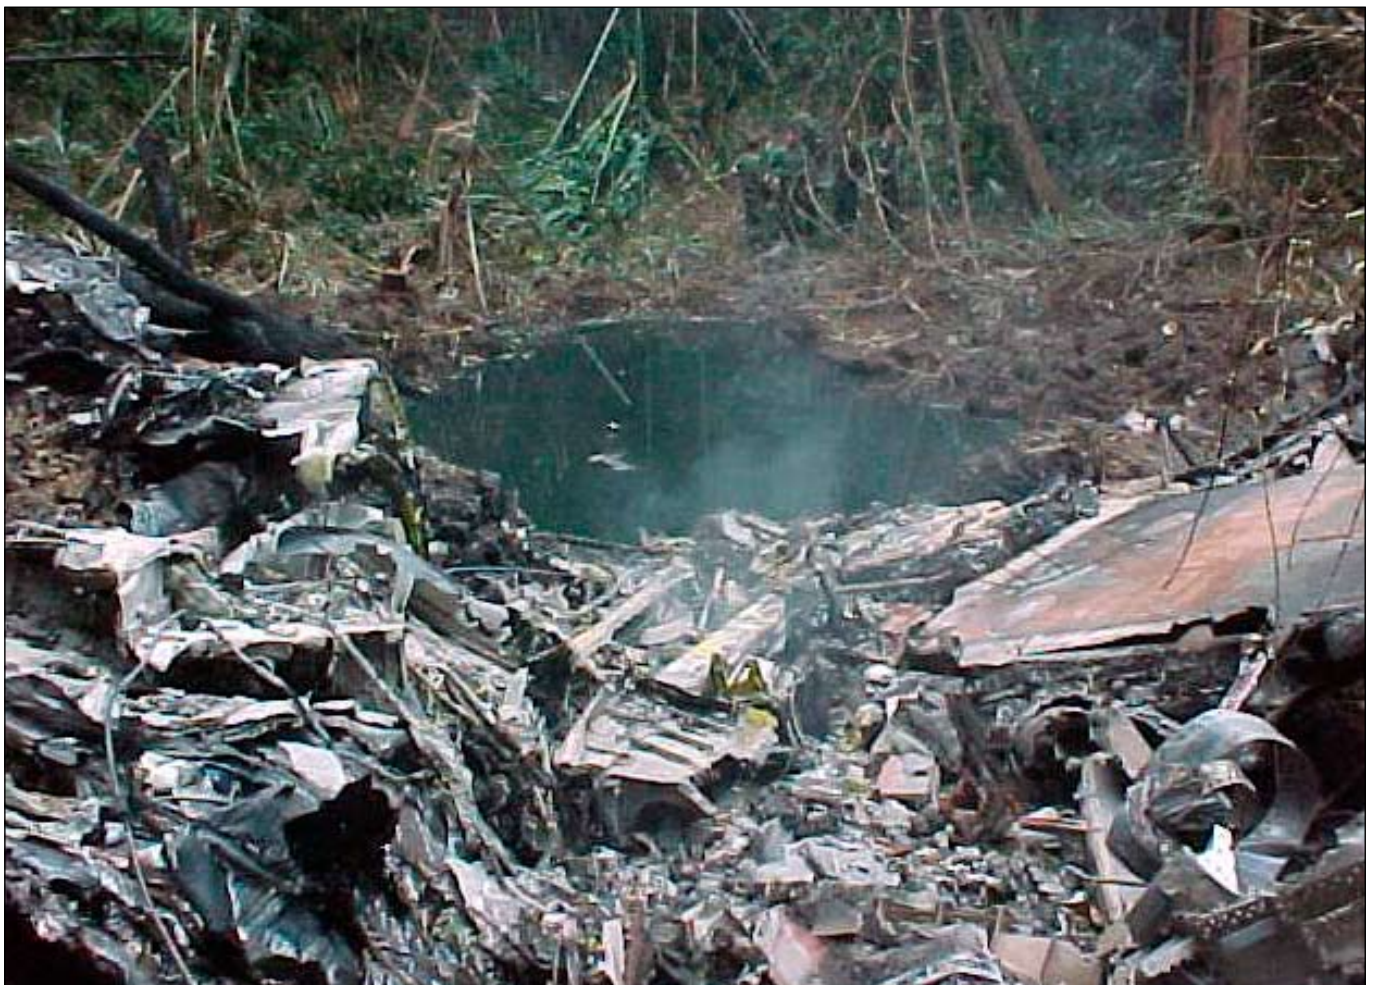
Below: Final impact crater Aur Island – aircraft A8-291.

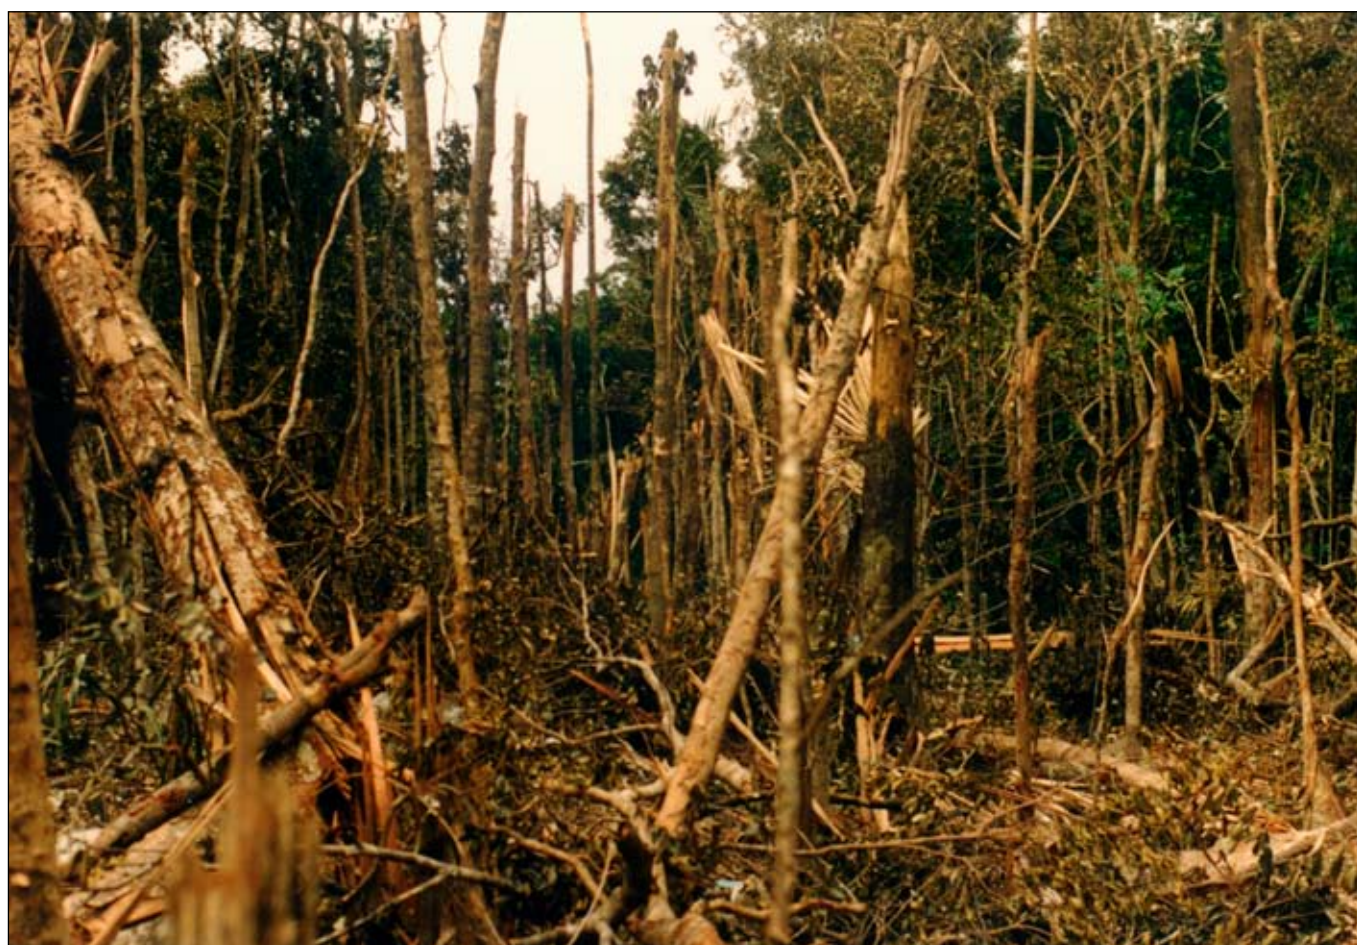
**Below: Felled trees looking back along flightpath on Great Palm Island – aircraft A21-104.**

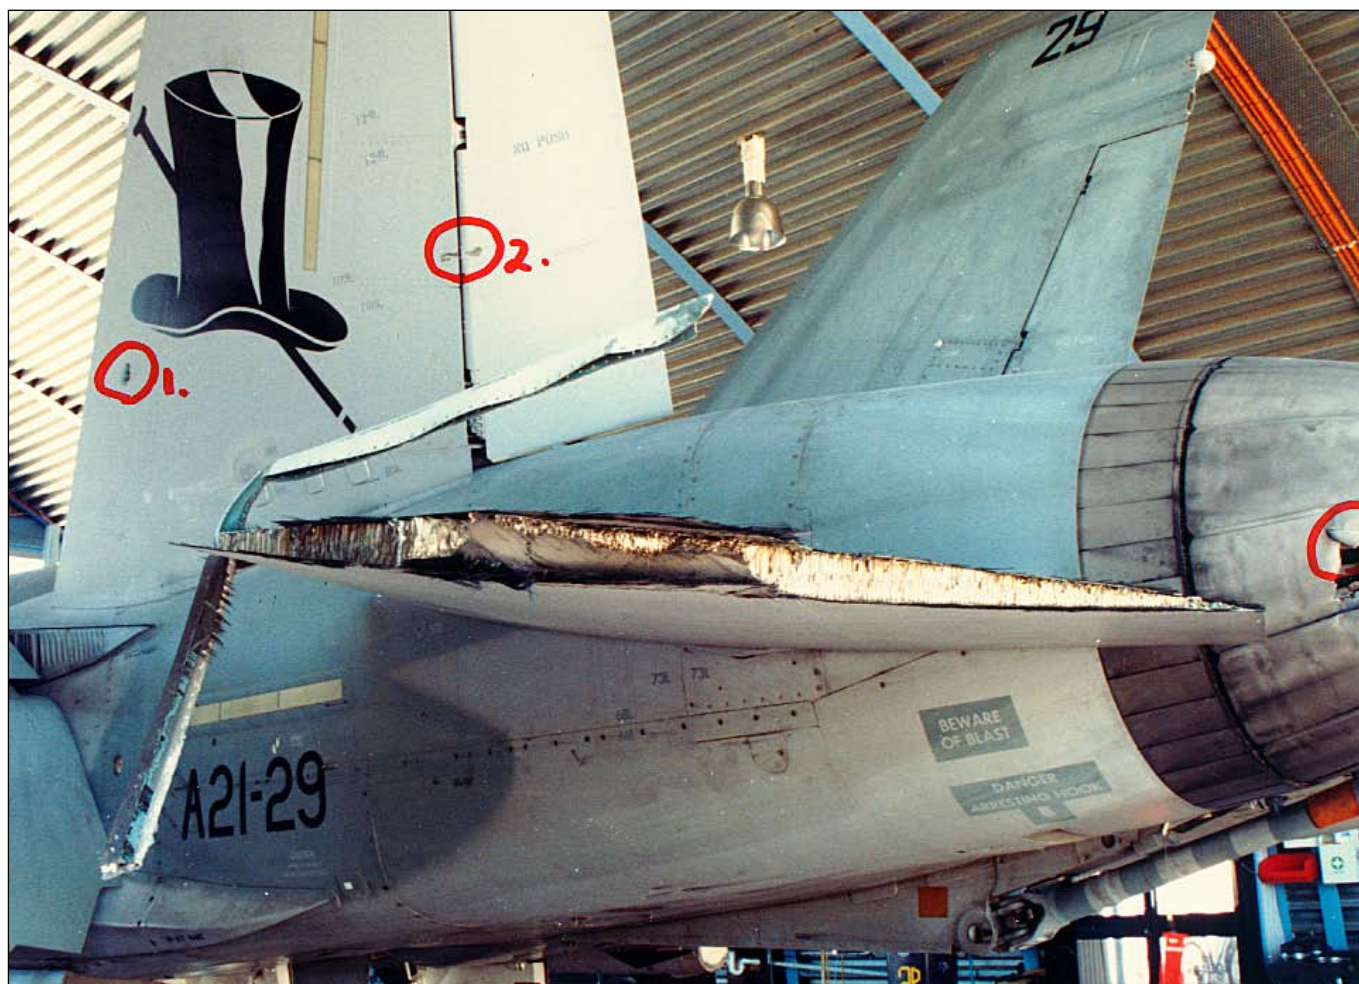
Below: Collision damage to wingman's aircraft – aircraft A21-29.

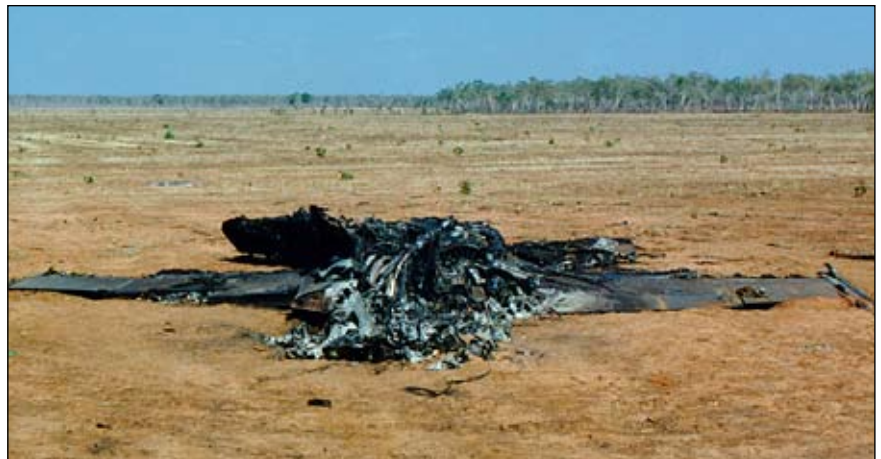
Above: Main wreckage (the nose and a portion of the cockpit had separated in flight - aircraft A21-42.

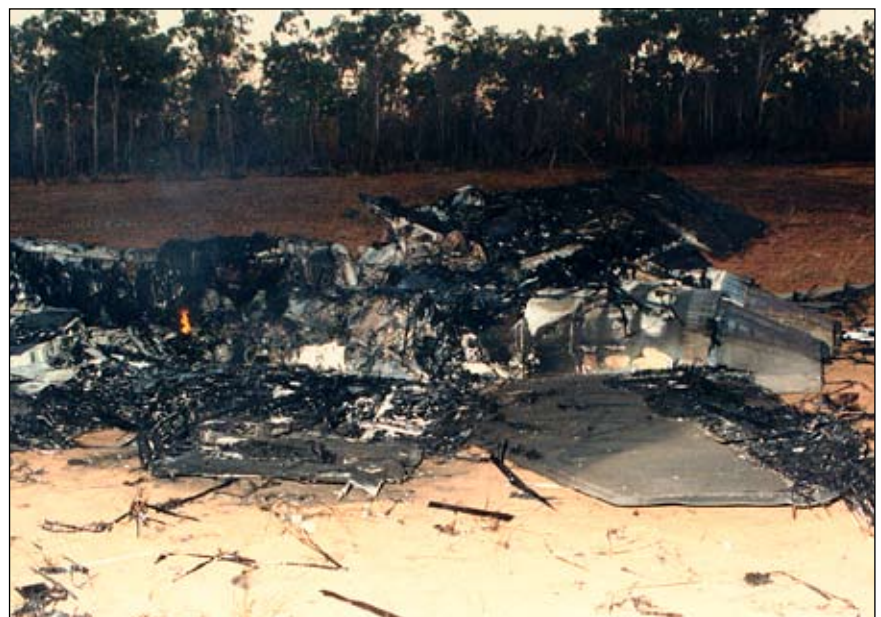
Below: Carbon fibre hazard - aircraft A21-42.

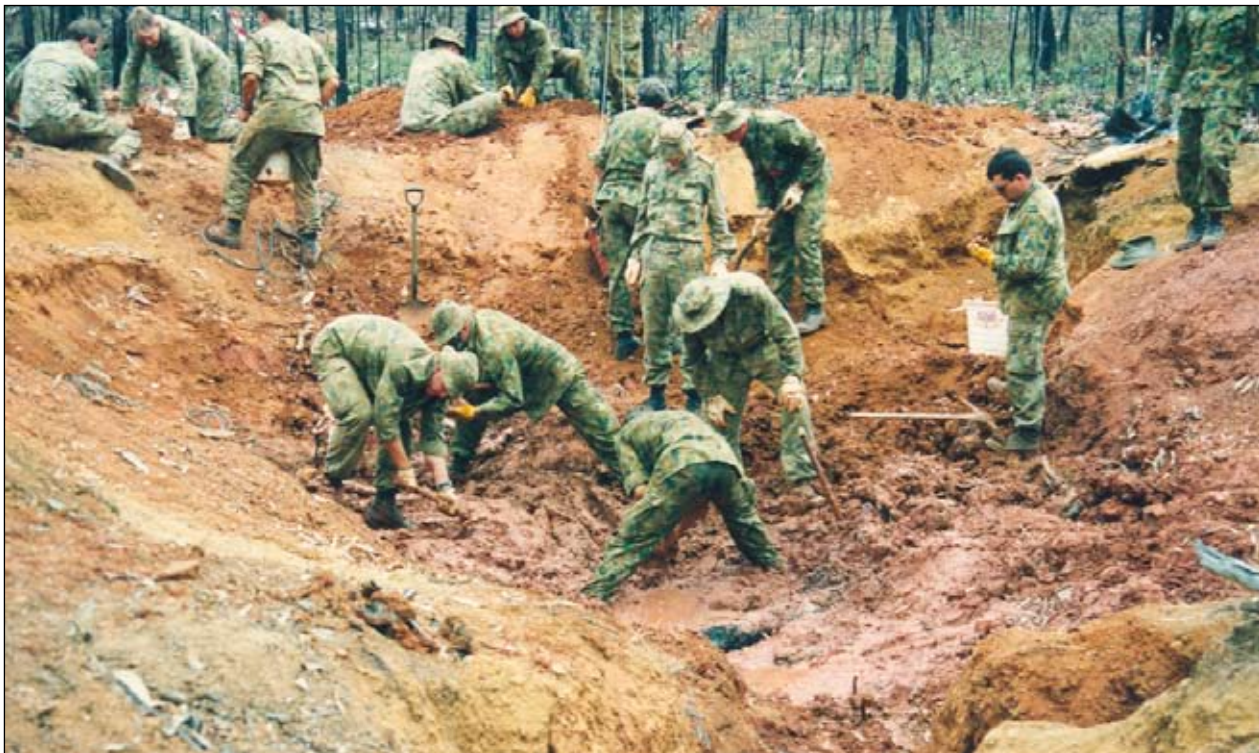
**Below: Wreckage recovery – aircraft A21-41.**

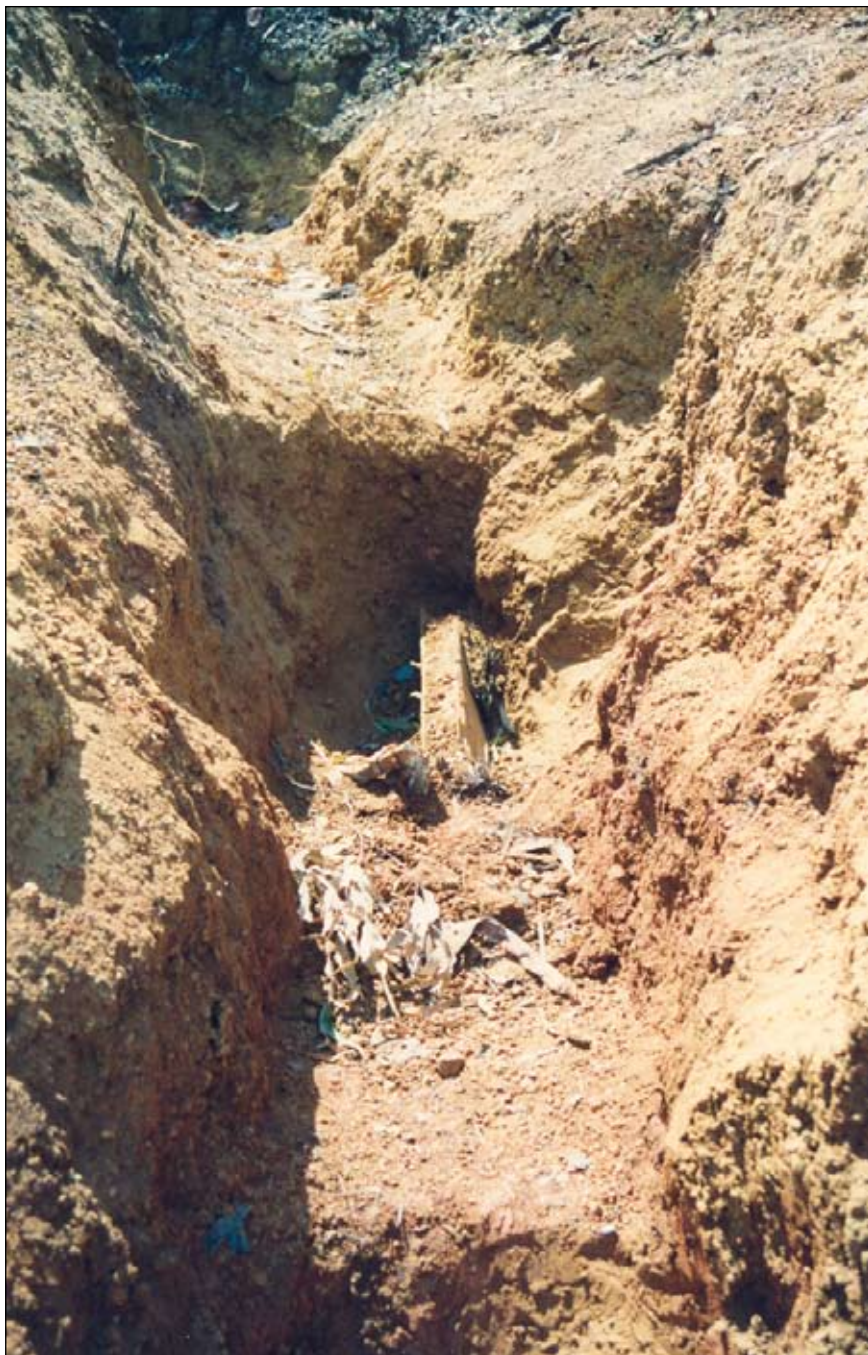
Above: Wing recovery – aircraft A21-41.

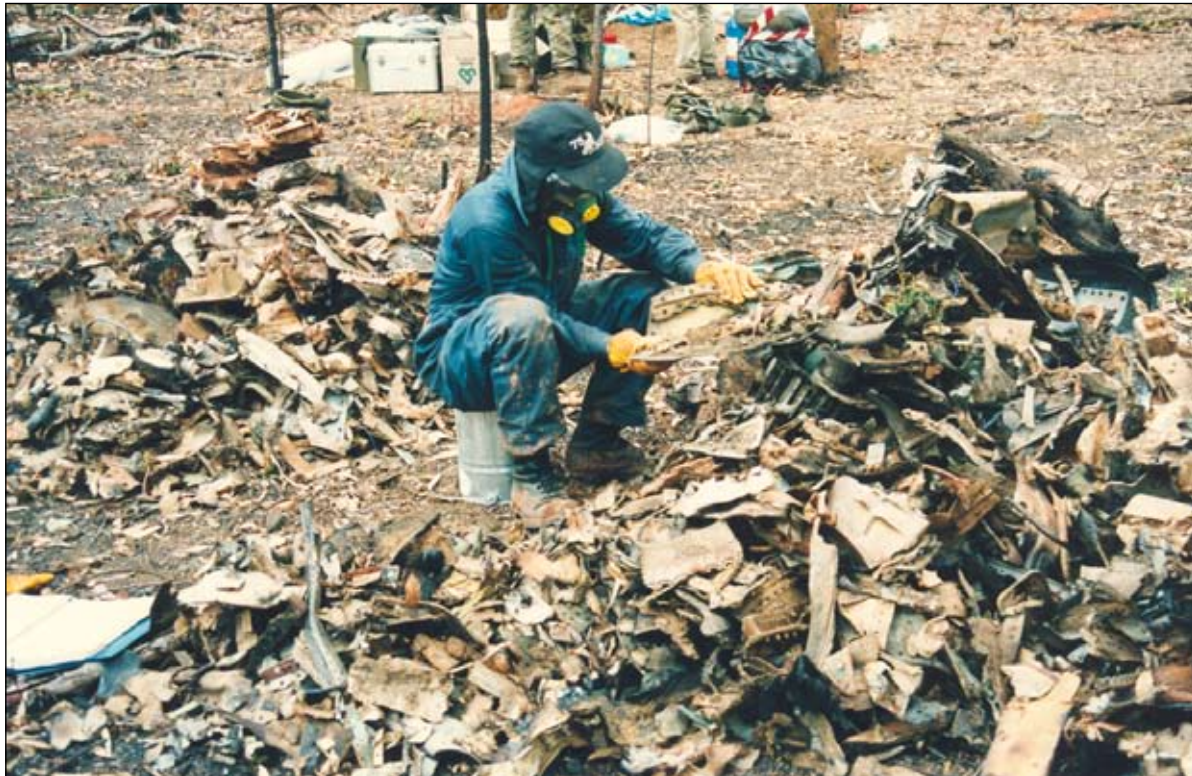
Above: Wreckage examination – aircraft A21-41.

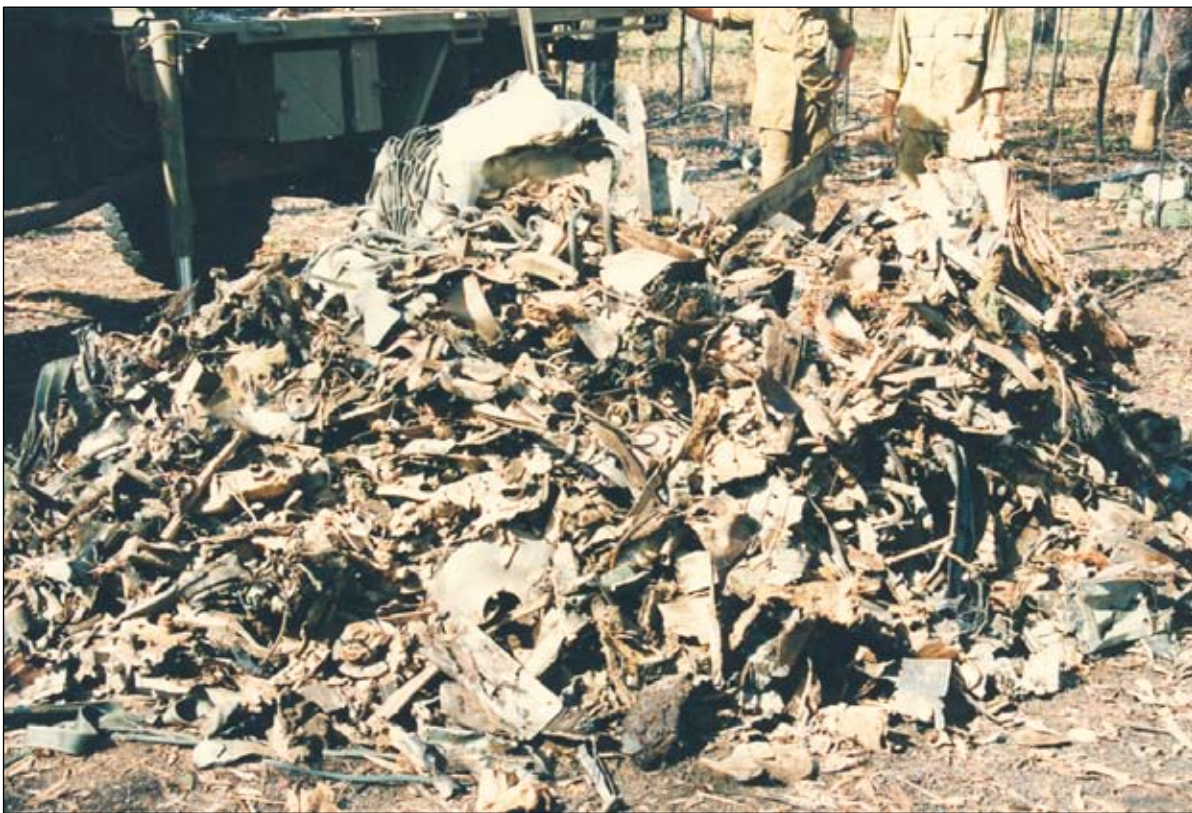
Above: Wreckage pile – aircraft A21-41.

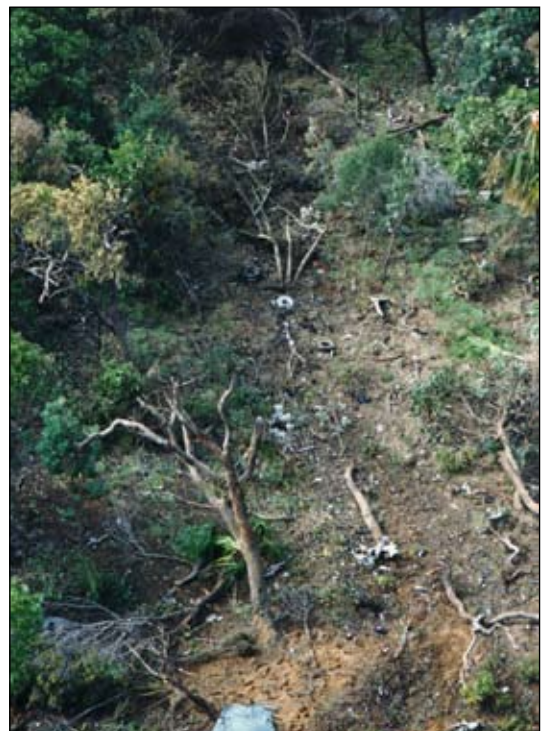
Above: Crash site at Shoalwater Bay Training Area – aircraft A21-106.

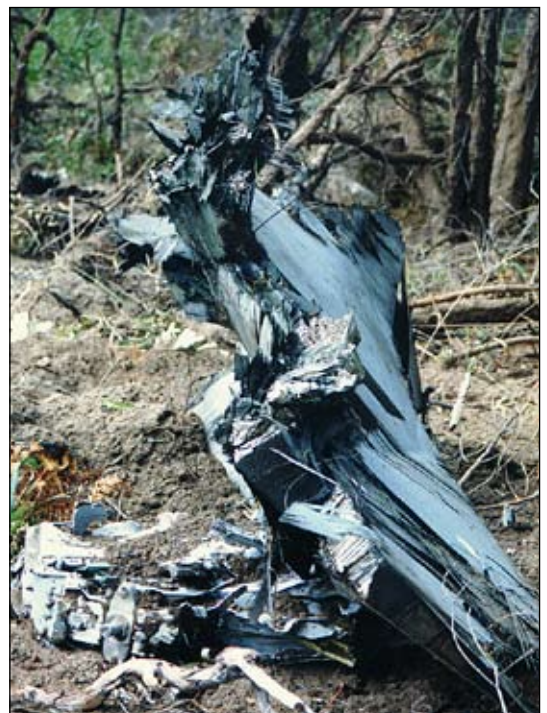
Below: Stabiliser – aircraft A21-106.
