70-2388 F-111F # 27 GD/FW Production Run # E2-27

Mar 16, 1976 Crashed on on the Mtn Home AFB Runway.

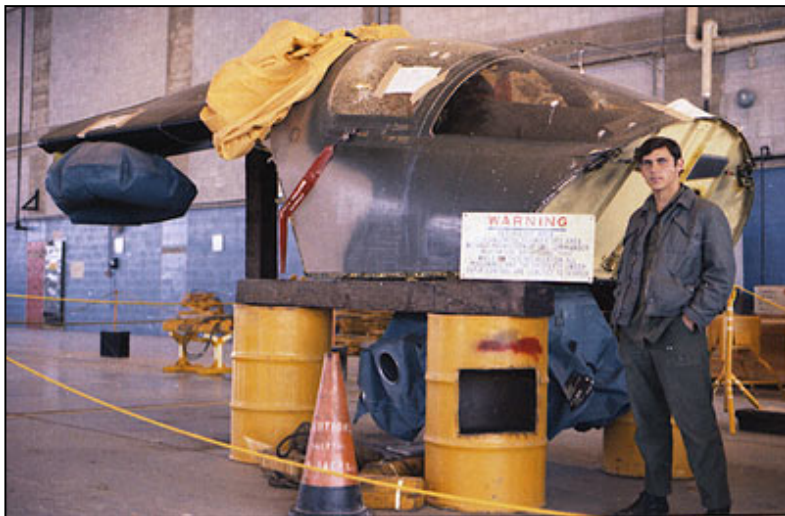
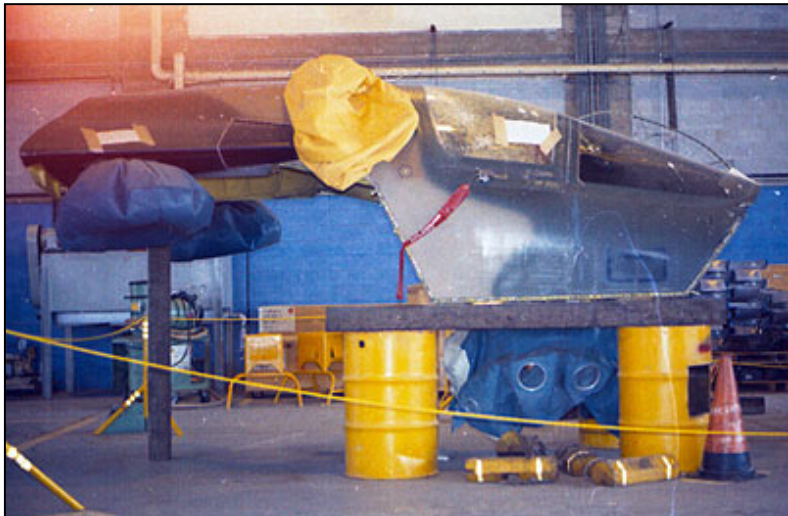
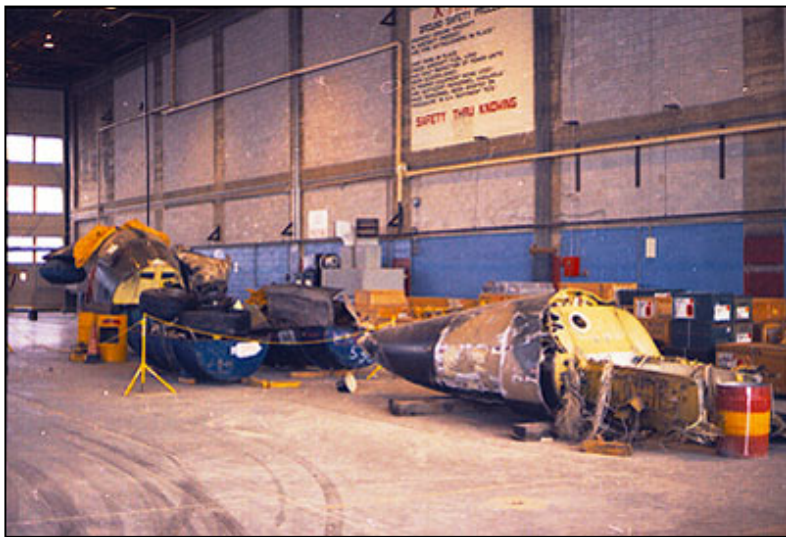
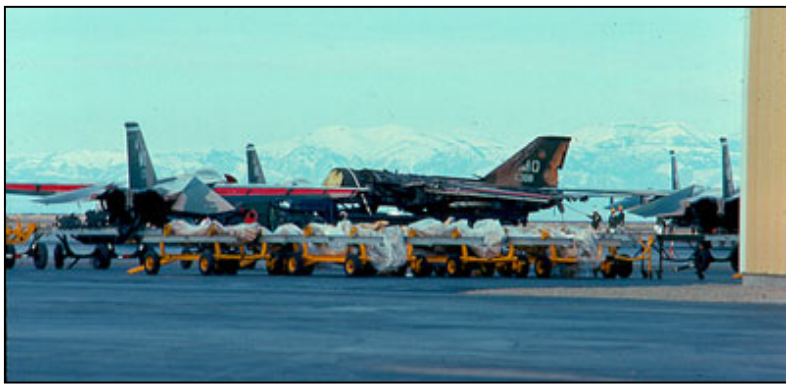
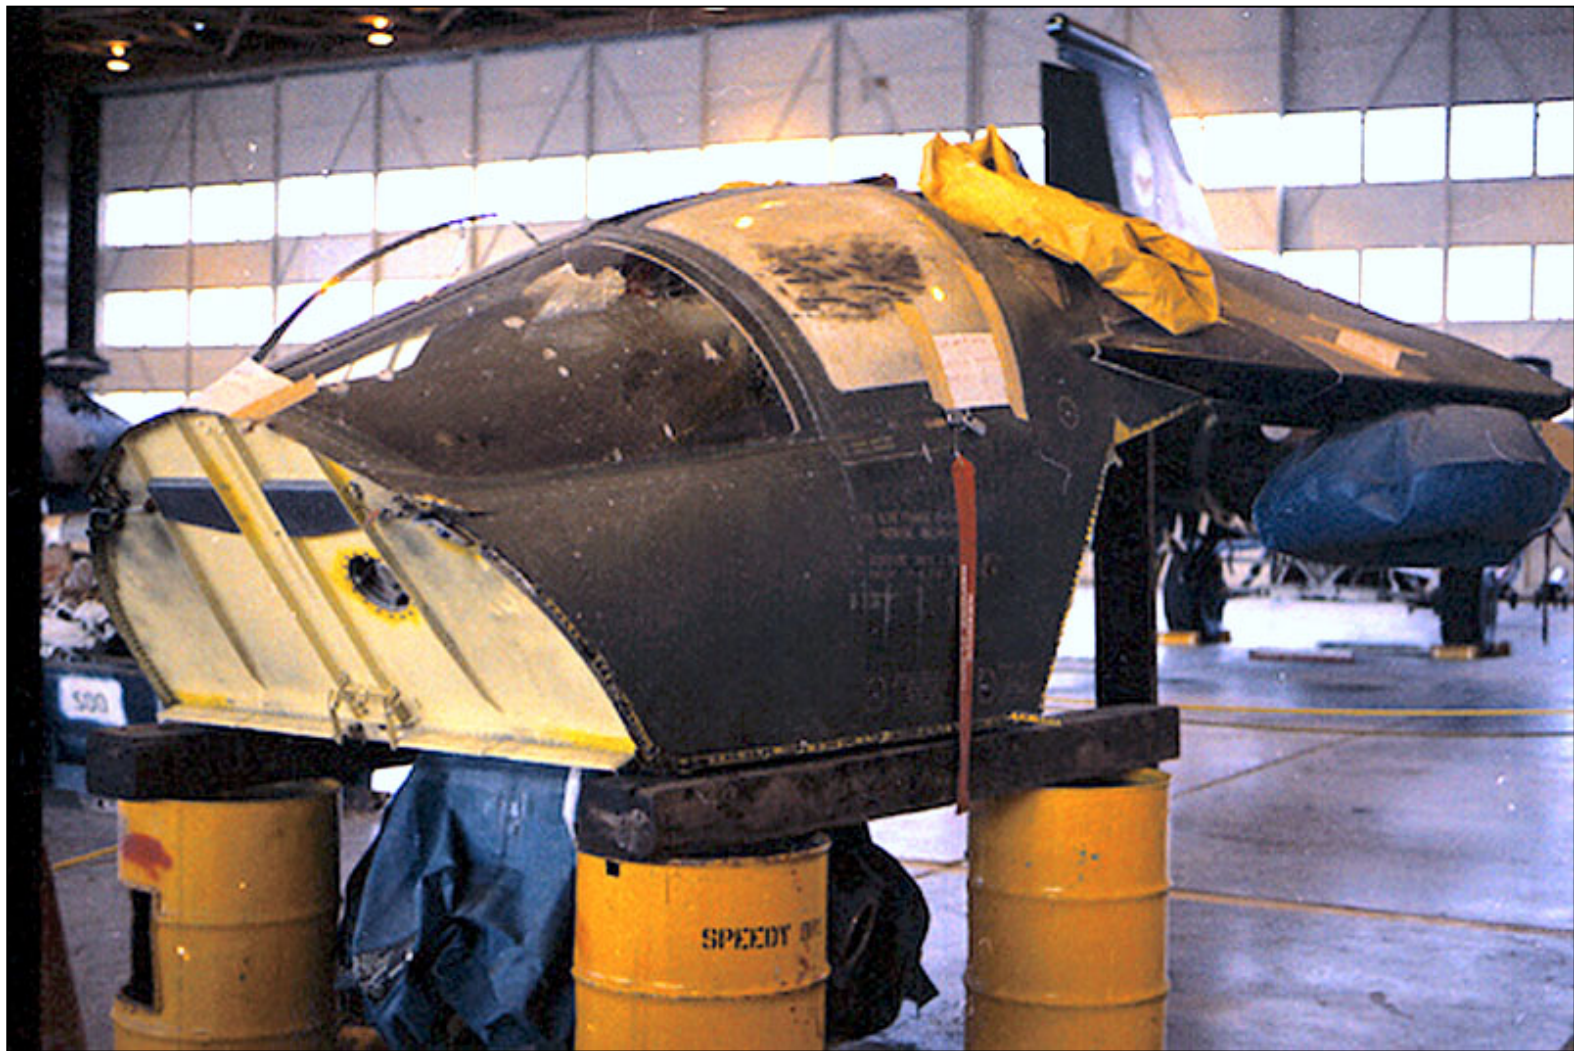
above photos were taken in hangar 211 - US DoD

You'll notice that the upper flotation righting bag is deflated, and the glass in the entry/exit canopy section is all shattered. This happened when the capsule landed - it hit in the normal upright attitude, but the impact was so hard (we came down on the concrete runway) that the capsule bounced back up in the air, did a 180 degree roll, landed again (upside down this time, at which point all that glass shattered inwards into the cockpit), bounced once again, and finally landed and stayed right side up in the normal attitude. When it hit the second time and bounced and rolled, all the shattered glass flew everywhere - they were vacuuming glass out of our flight suits and boots and other kit for some time afterwards.

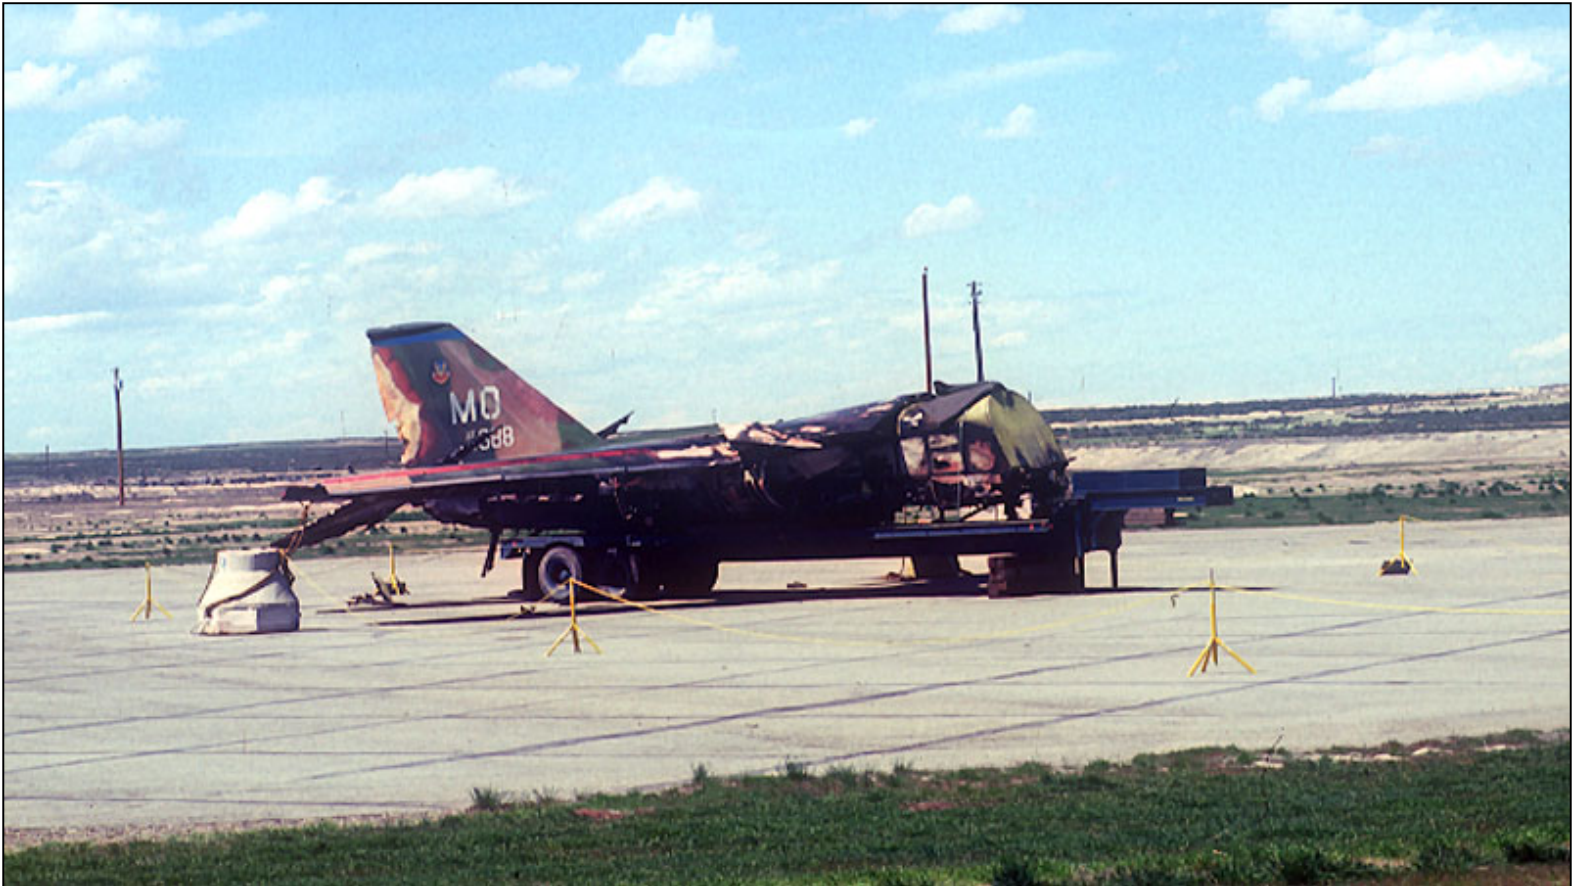
Shown after the crash on the Mtn Home AFB Runway US DoD
