# SIFTING THROUGH THE EVIDENCE

RAAF F-111 and AF/A-18 aircraft and crew losses

An aviation safety magazine of the Australian Defence Force

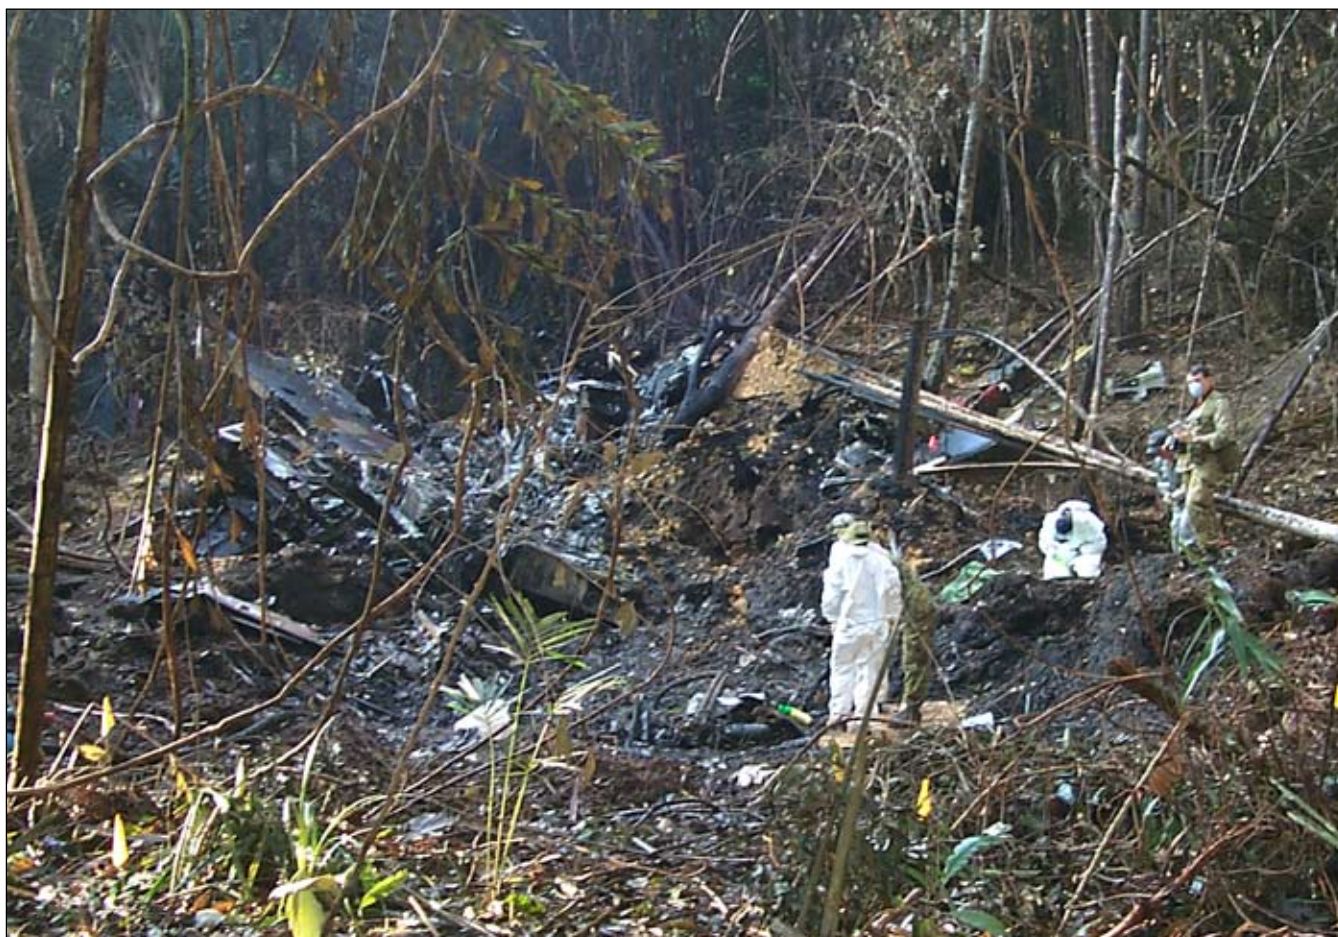
**Below: Sifting through the evidence – aircraft A8-291.**

48. This is the second F-111 accident occurring while simulating Harpoon missile flightpath.

49. Approximately one year after the accident another F-111 crew, while resetting for a night target attack, inadvertently found themselves within a quarter mile of the same island that A8-291 crashed into. The navigator did not see the island on radar because of task saturation and only realised where they were when he saw the lights of fishing vessels disappearing behind the dark land mass of the island. While the aircraft was not on a direct course with the island and the crew were flying with the TFRs engaged, it is disconcerting that all other defences had failed and that the TFR was effectively providing the last line of defence.
