## **Extracts from DDAAFS Safety Magazine**

### **“SIFTING THROUGH THE EVIDENCE”**

#### **29 September 1977 (F-111C A8-133) – 2<sup>nd</sup> F-111 accident – birdstrike and ejection Evans Head**

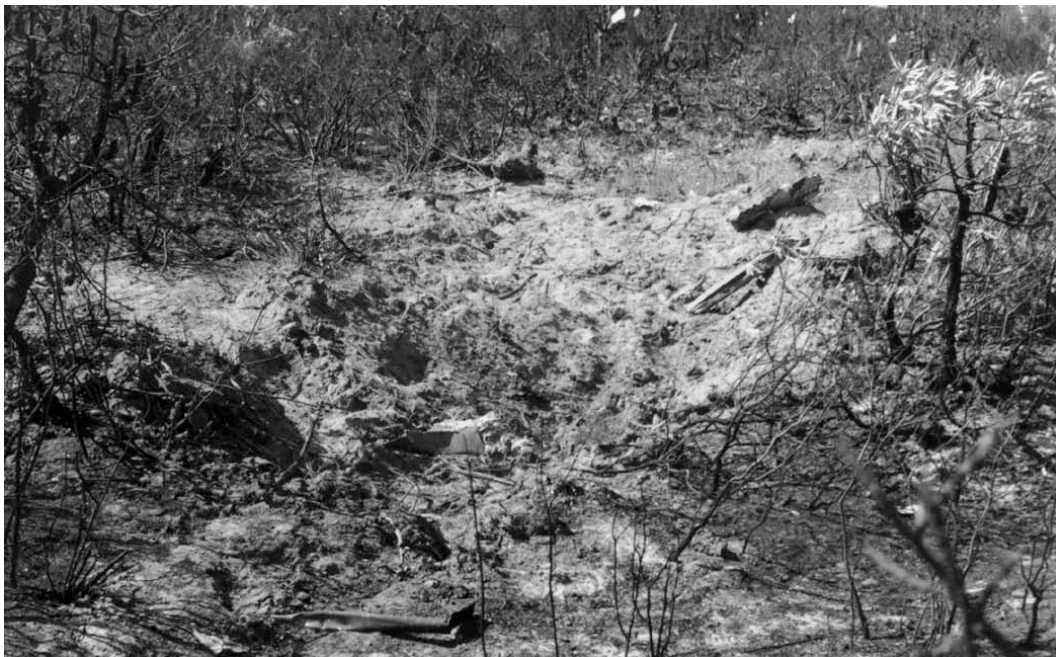
**Crew module crater – aircraft A8-133**

Ejection occurred at 520 kts, 720 ft AMSL, nose down and right wing down. Ejection parameters were well beyond the capabilities of the crew module, which impacted the ground approximately three seconds later, nose down and with approximately 55° right bank. The module disintegrated on impact.

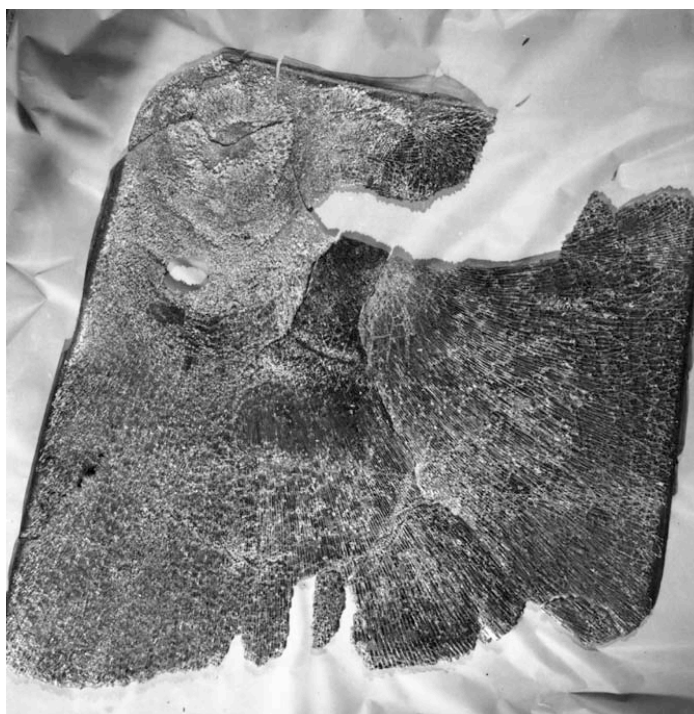
Accident reconstruction indicated that shortly after straightening for the downwind leg, the aircraft's transparencies were shattered by a collision with at least one and probably three large birds.<sup>2</sup> The pilot under instruction was most likely totally incapacitated by injuries inflicted by both bird and windshield debris.<sup>3</sup> The instructor pilot may have been similarly incapacitated, but probably to a lesser degree. However, the instructor pilot would have been effectively blinded at this stage by high energy glass fragments, bird tissue and shredded fibreglass. Between 10–12 seconds after the birdstrike, ejection was initiated, almost certainly by the instructor pilot.

<sup>2</sup> Points of impact were determined to be the left and right windscreens and left canopy.

<sup>3</sup> The left-seat occupant was likely unconscious following the initial birdstrike, having been hit on the right side of the forehead with such force that the visor cover and both visors were broken, at the same time his head was forced back with such violence that his helmet left a ¾ inch depression in the metal seat back structure.

**Birdstrike damage to pilot's side canopy – aircraft A8-133**

Board recommendations included that more emphasis should be given during F-111C crew briefing on post-birdstrike procedures, to the drastic consequences of birdstrike while the aircraft is being flown manually.<sup>5</sup> Strong consideration should be given to ejection as an immediate action, particularly if the bird impacts the left windshield.

1. Fitment of the Bird Impact Resistant Transparencies (BIRT).<sup>6</sup>
2. 82WG Standing Instructions provide advice that ejection should be considered if any doubt exists as to the controllability of the aircraft, particularly when at low altitude, following a bird strike that penetrates the F-111 windscreen(s).

<sup>6</sup> If the birds were in fact pelican-sized, canopy penetration may still have occurred, even if BIRT were fitted.
